Access Compliance Report

Public Rights-of-Way

(Curb Ramps)

Intersection ID: 10023486	Main Street: CIRCUMFERENTIAL_RD	Cross Street: N/A	Location: SW
ADA ID: 974042FE3589	Ramp Type: Perp	Initial Pass/Fail: Pass	Overall Compliance: No
			Severity Score: 2.5

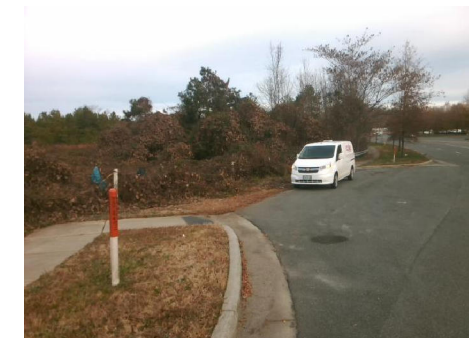
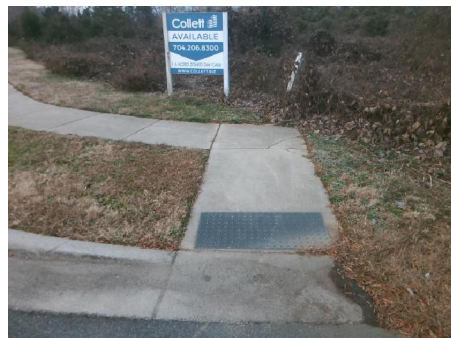
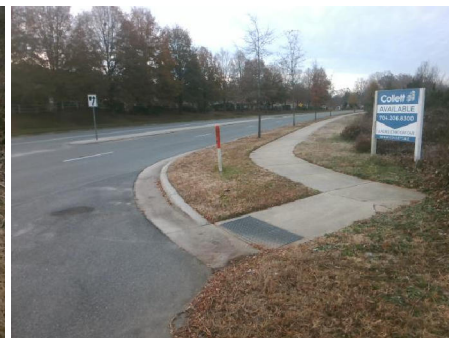
Compliance	Description	Data	Compliance	Description	Data
N/A	Ramp Length (in)	97.0	Yes	Ramp Slope (%)	6.1
Yes	Ramp Width (in)	58.0	Yes	Ramp XSlope (%)	1.4
N/A	Flare Type LT	None	N/A	Flare Type RT	N/A
N/A	Flare Slope LT (%)	N/A	N/A	Flare Slope RT (%)	N/A
N/A	Flare Traversable LT?	N/A	N/A	Flare Traversable RT?	N/A
Yes	Landing Length (in)	59.0	Yes	DWS Provided?	Yes
Yes	Landing Width (in)	57.0	Yes	DWS Contrast?	Yes
Yes	Landing Slope (%)	0.5	Yes	DWS Length (in)	24.0
Yes	Landing X Slope (%)	1.0	No	DWS Full Width?	No
N/A	Landing Curb? (Y/N)	No	Yes	DWS Offset (in)	2.0
N/A	Shared Landing?	No			
Yes	Gutter Ponding?	No	Yes	Gutter Slope (%)	0.3
Yes	Gutter Lip Ht (in)	0.0	Yes	Gutter X Slope (%)	2.6
N/A	Painted X Walk1?	No	N/A	Painted X Walk2?	N/A
	X Walk 1 Direction	To N		X Walk 2 Direction	N/A
N/A	X Walk 1 Width (in)	N/A	N/A	X Walk 2 Width (in)	N/A
	X Walk 1 Slope (%)	0.1		X Walk 2 Slope (%)	N/A
	X Walk 1 X Slope (%)	3.1		X Walk 2 X Slope (%)	N/A

N/A	Ramp inside XWalk1?	N/A	N/A	Ramp inside XWalk2?	N/A
	Road Slope (%)	N/A	N/A	Clear Space?	Yes
	Road X Slope (%)	N/A	N/A	Clear Space to XWalk (in)	N/A
Yes	Any Obstructions?	No	Yes	Storm Grate/Utility Hazard?	No
	Obstruction Type			Storm Grate/Utility Type	
		N/A			N/A
			Yes	Surface Condition? (G/P)	Good

Remove & Replace Detectable Warning System.

R305.1.4

\$ 800.00
