# Access Compliance Report

## Public Rights-of-Way

| Intersection ID: 10093 | Main Street: MILTON_RD | Cross Street: THE_PLAZA | Location: SW |
| ADA ID: 974AA3EE2EB5 | Ramp Type: Perp | Initial Pass/Fail: Fail | Overall Compliance: No |

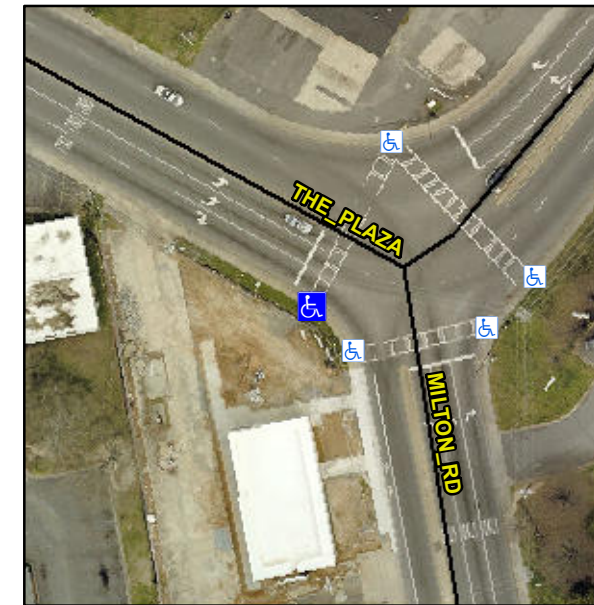
**Not Found, R304.5.1, R304.2.2, R304.5.3**

| Compliance | Description | Data | Compliance | Description | Data |
|---|---|---|---|---|---|
| N/A | Ramp Length (in) | 59.0 | No | Ramp Slope (%) | 10.9 |
| No | Ramp Width (in) | 46.0 | No | Ramp XSlope (%) | 4.0 |

**Remove & Replace Entire Ramp.**
