# Access Compliance Report

## Public Rights-of-Way

### (Curb Ramps)

Intersection ID: 48450	Main Street: DUSTY_SADDLE_RD	Cross Street: RED_RUST_LN	Location: NW
ADA ID: 9750B35653BC	Ramp Type: Perp	Initial Pass/Fail: Fail	Overall Compliance: No
Severity Score: 8.75			
Codes/Mitigation Info/Possible Solution		Field Measurements/Component Compliance

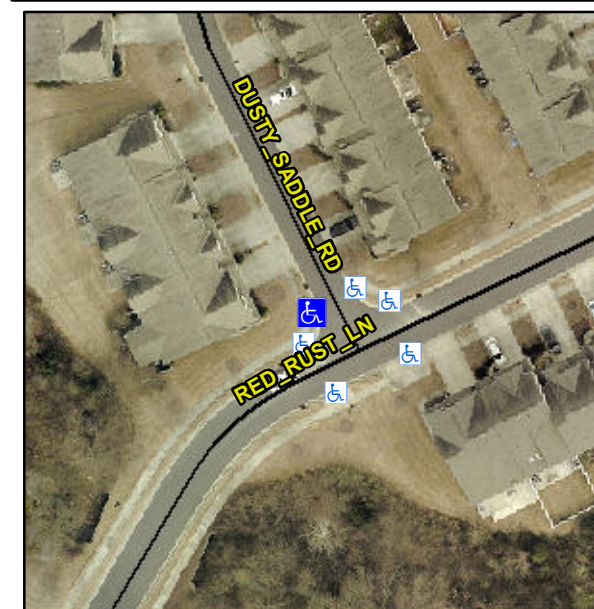
**Not Found, R304.5.1**

Compliance	Description	Data	Compliance	Description	Data
N/A	Ramp Length (in)	38.0	Yes	Ramp Slope (%)	5.1
No	Ramp Width (in)	46.0	Yes	Ramp XSlope (%)	0.3
N/A	Flare Type LT	N/A	N/A	Flare Type RT	N/A
N/A	Flare Slope LT (%)	N/A	N/A	Flare Slope RT (%)	N/A
N/A	Flare Traversable LT?	N/A	N/A	Flare Traversable RT?	N/A
N/A	Landing Length (in)	N/A	N/A	DWS Provided?	N/A
N/A	Landing Width (in)	N/A	N/A	DWS Contrast?	N/A
N/A	Landing Slope (%)	N/A	N/A	DWS Length (in)	N/A
N/A	Landing X Slope (%)	N/A	N/A	DWS Full Width?	N/A
N/A	Landing Curb? (Y/N)	N/A	N/A	DWS Offset (in)	N/A
N/A	Shared Landing?	N/A			
N/A	Gutter Ponding?	N/A	N/A	Gutter Slope (%)	N/A
N/A	Gutter Lip Ht (in)	N/A	N/A	Gutter X Slope (%)	N/A
N/A	Painted X Walk1?	No	N/A	Painted X Walk2?	N/A
	X Walk 1 Direction	To NE		X Walk 2 Direction	N/A
N/A	X Walk 1 Width (in)	N/A	N/A	X Walk 2 Width (in)	N/A
	X Walk 1 Slope (%)	0.7		X Walk 2 Slope (%)	N/A
	X Walk 1 X Slope (%)	0.7		X Walk 2 X Slope (%)	N/A

N/A	Ramp inside XWalk1?	N/A	N/A	Ramp inside XWalk2?	N/A
	Road Slope (%)	N/A	N/A	Clear Space?	N/A
	Road X Slope (%)	N/A	N/A	Clear Space to XWalk (in)	N/A
N/A	Any Obstructions?	N/A	N/A	Storm Grate/Utility Hazard?	N/A
	Obstruction Type			Storm Grate/Utility Type	
		N/A			N/A
		Yes		Surface Condition? (G/P)	Good

**Remove & Replace Entire Ramp.**

Total Cost: \$ 1850.00
