Access Compliance Report

Public Rights-of-Way

(Curb Ramps)

Intersection ID: 10031826	Main Street: MILLWRIGHT_LN	Cross Street: N/A	Location: SE
ADA ID: 9752B24DB8EB	Ramp Type: BlendTrans1	Initial Pass/Fail: Fail	Overall Compliance: No
		Severity Score: 25

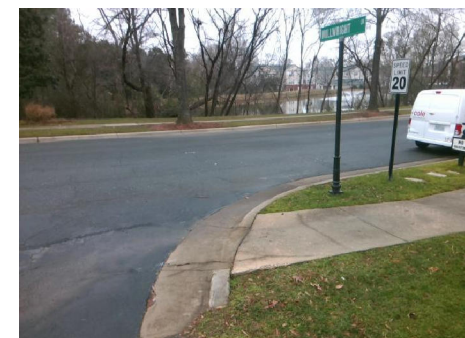
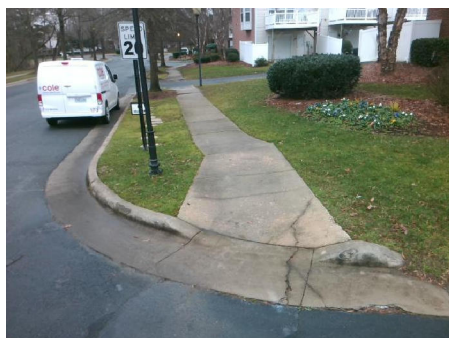
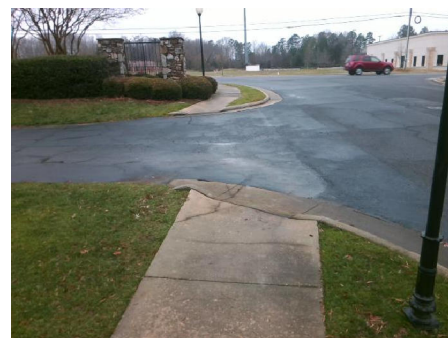
Compliance	Description	Data	Compliance	Description	Data
N/A	Ramp Length (in)	60.0	Yes	BlendTrans Slope (%)	3.2
Yes	Ramp Width (in)	60.0	No	BlendTrans XSlope (%)	9.4
N/A	Flare Type LT	N/A	N/A	Flare Type RT	N/A
N/A	Flare Slope LT (%)	N/A	N/A	Flare Slope RT (%)	N/A
N/A	Flare Traversable LT?	N/A	N/A	Flare Traversable RT?	N/A
N/A	Landing Length (in)	N/A	N/A	DWS Provided?	N/A
N/A	Landing Width (in)	N/A	N/A	DWS Contrast?	N/A
N/A	Landing Slope (%)	N/A	N/A	DWS Length (in)	N/A
N/A	Landing X Slope (%)	N/A	N/A	DWS Full Width?	N/A
N/A	Landing Curb? (Y/N)	N/A	N/A	DWS Offset (in)	N/A
N/A	Shared Landing?	N/A			
N/A	Gutter Ponding?	N/A	N/A	Gutter Slope (%)	N/A
N/A	Gutter Lip Ht (in)	N/A	N/A	Gutter X Slope (%)	N/A
N/A	Painted X Walk1?	No	N/A	Painted X Walk2?	N/A
	X Walk 1 Direction	To W		X Walk 2 Direction	N/A
	X Walk 1 Width (in)	N/A		X Walk 2 Width (in)	N/A
	X Walk 1 Slope (%)	1.9		X Walk 2 Slope (%)	N/A
	X Walk 1 X Slope (%)	1.3		X Walk 2 X Slope (%)	N/A

N/A	Ramp inside XWalk1?	N/A	N/A	Ramp inside XWalk2?	N/A
	Road Slope (%)	1.3		Clear Space?	N/A
	Road X Slope (%)	1.9	N/A	Clear Space to XWalk (in)	N/A
N/A	Any Obstructions?	N/A	N/A	Storm Grate/Utility Hazard?	N/A
	Obstruction Type			Storm Grate/Utility Type	
		N/A			N/A
			Yes	Surface Condition? (G/P)	Good
			No	Curb Slope (%)	7.5

Remove & Replace Curb Ramp With Two New Directional Ramps or Equivalent.
