Access Compliance Report

Public Rights-of-Way

(Curb Ramps)

Intersection ID: 44824	Main Street: CLANTON_RD	Cross Street: GOLDEN_RIDGE_LN	Location: SW
ADA ID: 975F81098E7F	Ramp Type: PerpDiag	Initial Pass/Fail: Fail	Overall Compliance: No
Severity Score: 26.25			
Codes/Mitigation Info/Possible Solution		Field Measurements/Component Compliance

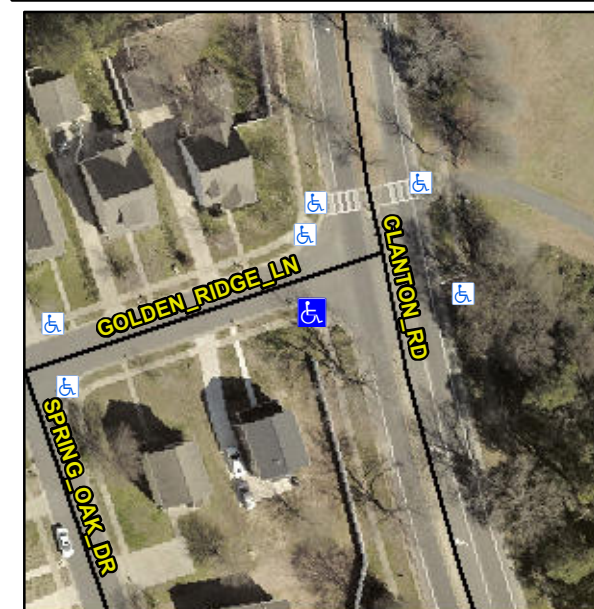
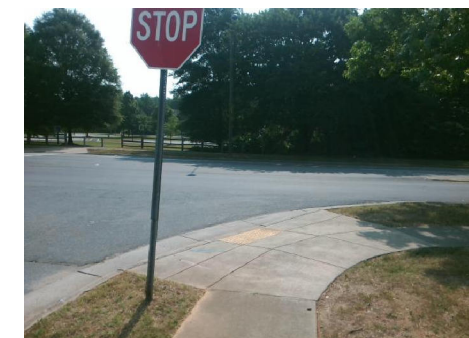
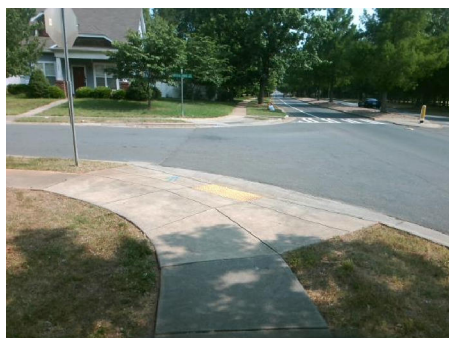
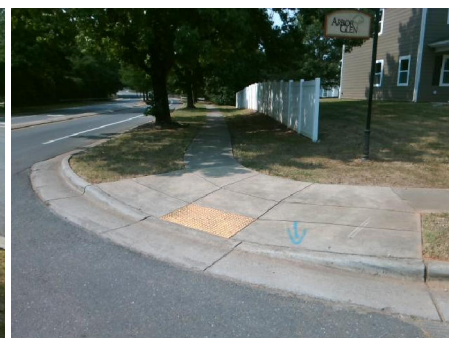
Not Found, R304.2.2, R304.5.3

Compliance	Description	Data	Compliance	Description	Data
N/A	Ramp Length (in)	51.0	No	Ramp Slope (%)	12.1
Yes	Ramp Width (in)	48.0	No	Ramp XSlope (%)	3.3
N/A	Flare Type LT	N/A	N/A	Flare Type RT	N/A
N/A	Flare Slope LT (%)	N/A	N/A	Flare Slope RT (%)	N/A
N/A	Flare Traversable LT?	N/A	N/A	Flare Traversable RT?	N/A
N/A	Landing Length (in)	N/A	N/A	DWS Provided?	N/A
N/A	Landing Width (in)	N/A	N/A	DWS Contrast?	N/A
N/A	Landing Slope (%)	N/A	N/A	DWS Length (in)	N/A
N/A	Landing X Slope (%)	N/A	N/A	DWS Full Width?	N/A
N/A	Landing Curb? (Y/N)	N/A	N/A	DWS Offset (in)	N/A
N/A	Shared Landing?	N/A			
N/A	Gutter Ponding?	N/A	N/A	Gutter Slope (%)	N/A
N/A	Gutter Lip Ht (in)	N/A	N/A	Gutter X Slope (%)	N/A
N/A	Painted X Walk1?	No	N/A	Painted X Walk2?	No
	X Walk 1 Direction	To E		X Walk 2 Direction	To N
N/A	X Walk 1 Width (in)	N/A	N/A	X Walk 2 Width (in)	N/A
	X Walk 1 Slope (%)	0.5		X Walk 2 Slope (%)	0.2
	X Walk 1 X Slope (%)	2.3		X Walk 2 X Slope (%)	1.7

N/A	Ramp inside XWalk1?	N/A	N/A	Ramp inside XWalk2?	N/A
	Road Slope (%)	1.5	N/A	Clear Space?	N/A
	Road X Slope (%)	1.3	N/A	Clear Space to XWalk (in)	N/A
N/A	Any Obstructions?	N/A	N/A	Storm Grate/Utility Hazard?	N/A
	Obstruction Type			Storm Grate/Utility Type	
		N/A			N/A
		Yes		Surface Condition? (G/P)	Good

Remove & Replace Curb Ramp With Two New Directional Ramps or Equivalent.
