# Access Compliance Report

## Public Rights-of-Way

### (Curb Ramps)

Intersection ID: 42670	Main Street: WALLACE_CABIN_DR	Cross Street: WALLACE_CREEK_LN	Location: SE
ADA ID: 97624A3EABE9	Ramp Type: PerpDiag	Initial Pass/Fail: Fail	Overall Compliance: No
		Severity Score: 8.75

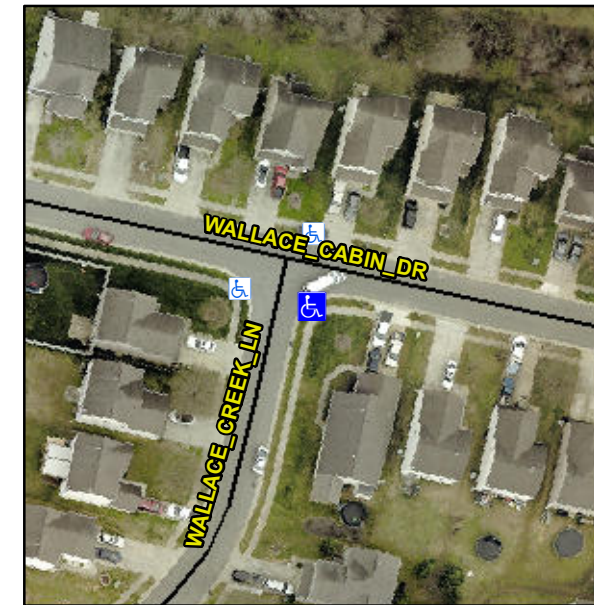
Compliance	Description	Data	Compliance	Description	Data
N/A	Ramp Length (in)	50.5	Yes	Ramp Slope (%)	5.0
No	Ramp Width (in)	37.5	Yes	Ramp XSlope (%)	1.9
N/A	Flare Type LT	N/A	N/A	Flare Type RT	N/A
N/A	Flare Slope LT (%)	N/A	N/A	Flare Slope RT (%)	N/A
N/A	Flare Traversable LT?	N/A	N/A	Flare Traversable RT?	N/A
N/A	Landing Length (in)	N/A	N/A	DWS Provided?	N/A
N/A	Landing Width (in)	N/A	N/A	DWS Contrast?	N/A
N/A	Landing Slope (%)	N/A	N/A	DWS Length (in)	N/A
N/A	Landing X Slope (%)	N/A	N/A	DWS Full Width?	N/A
N/A	Landing Curb? (Y/N)	N/A	N/A	DWS Offset (in)	N/A
N/A	Shared Landing?	N/A			
N/A	Gutter Ponding?	N/A	N/A	Gutter Slope (%)	N/A
N/A	Gutter Lip Ht (in)	N/A	N/A	Gutter X Slope (%)	N/A
N/A	Painted X Walk1?	No	N/A	Painted X Walk2?	No
	X Walk 1 Direction	To N		X Walk 2 Direction	To W
N/A	X Walk 1 Width (in)	N/A	N/A	X Walk 2 Width (in)	N/A
	X Walk 1 Slope (%)	2.4		X Walk 2 Slope (%)	0.8
	X Walk 1 X Slope (%)	0.0		X Walk 2 X Slope (%)	3.9

N/A	Ramp inside XWalk1?	N/A	N/A	Ramp inside XWalk2?	N/A
	Road Slope (%)	3.7	N/A	Clear Space?	N/A
	Road X Slope (%)	2.9	N/A	Clear Space to XWalk (in)	N/A
N/A	Any Obstructions?	N/A	N/A	Storm Grate/Utility Hazard?	N/A
	Obstruction Type			Storm Grate/Utility Type	
		N/A			N/A
		Yes		Surface Condition? (G/P)	Good

**Remove & Replace Curb Ramp With Two New Directional Ramps or Equivalent.**

**R304.5.1**

Total Cost: \$ 3200.00
