Access Compliance Report Public Rights-of-Way (Curb Ramps)

Intersection ID: 21433 Main Street: PARK_RD Cross Street: SPRING_VALLEY_RD Location: NE **Overall Compliance: No** Severity Score: 13.75 ADA ID: 976AEBB707BC Ramp Type: Perp Initial Pass/Fail: Fail

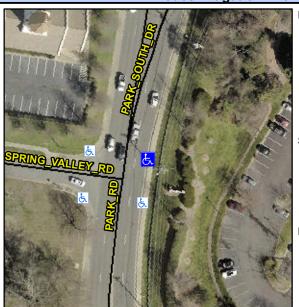
Field Measurements/Component Compliance						
Comp	liance Description	Data	Comp	liance	Description	Data
N/A	Ramp Length (in)	60.0	No	Ram	Slope (%)	9.6
Yes	Ramp Width (in)	48.0	No	Ram	XSlope (%)	4.3
N/A	Flare Type LT	N/A	N/A	Flare	Type RT	N/A
N/A	Flare Slope LT (%)	N/A	N/A	Flare	Slope RT (%)	N/A
N/A	Flare Traversable LT?	N/A	N/A	Flare	Traversable RT?	N/A
N/A	Landing Length (in)	N/A	N/A	DWS	Provided?	N/A
N/A	Landing Width (in)	N/A	N/A	DWS	Contrast?	N/A
N/A	Landing Slope (%)	N/A	N/A	DWS	Length (in)	N/A
N/A	Landing X Slope (%)	N/A	N/A	DWS	Full Width?	N/A
N/A	Landing Curb? (Y/N)	N/A	N/A	DWS	Offset (in)	N/A
N/A	Shared Landing?	N/A				
N/A	Gutter Ponding?	N/A	N/A	Gutte	er Slope (%)	N/A
N/A	Gutter Lip Ht (in)	N/A	N/A	Gutte	r X Slope (%)	N/A
N/A	Painted X Walk1?	No	N/A	Paint	ed X Walk2?	N/A
	X Walk 1 Direction	To NW		X Wa	lk 2 Direction	N/A
N/A	X Walk 1 Width (in)	N/A	N/A	X Wa	lk 2 Width (in)	N/A
	X Walk 1 Slope (%)	2.0		X Wa	lk 2 Slope (%)	N/A

X Walk 1 X Slope (%)	1.8		X Wa	lk 2 X Slope (%)	N/A
N/A	Ramp inside XWalk1?	N/A	N/A	Ram	inside XWalk2?	N/A
	Road Slope (%)	N/A	N/A	Clear	Space?	N/A
	Road X Slope (%)	N/A	N/A	Clear	Space to XWalk (in)	N/A
N/A	Any Obstructions?	N/A	N/A	Storn	n Grate/Utility Hazard?	N/A
	Obstruction Type			Storn	n Grate/Utility Type	
		N/A				N/A
			Yes	Surfa	ce Condition? (G/P)	Good

Possible Solutions:	<u>C</u>
Remove & Replace Entire Ramp.	
	Υ
	N
	N
	N
	N
Surveyor Notes:	N
N/A	N
	N
	N
	N
PROW/ADA:	N
Not Found, R304.2.2, R304.5.3	
	N
	N
	N
