Access Compliance Report Public Rights-of-Way (Curb Ramps)

Intersection ID: 10071 Main Street: E_36TH_ST Cross Street: YADKIN_AV Location: SW ADA ID: 976D7EF22C84 Ramp Type: PerpDiag Initial Pass/Fail: Fail **Overall Compliance: No Severity Score:** 10

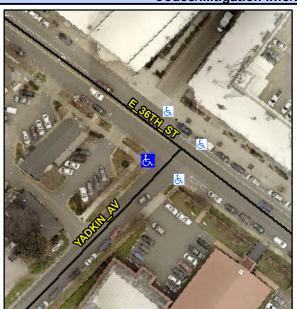
YADKIN AV Street 1 Name Stop Condition-Street 2 StopSign Street 2 Name E 36TH ST Stop Condition-Street 1 None

| Field Measurements/Component Compliance | | | | | |
|---|---|---|---|---|---|
| No | Ramp Width (in) | 47.5 | No | Ramp XSlope (%) | 2.3 |

Possible Solutions: Remove & Replace Curb Ramp With Two New Directional Ramps or Equivalent. Surveyor Notes: N/A PROW/ADA: Not Found, R304.5.1, R304.5.3
