Access Compliance Report

Public Rights-of-Way

(Curb Ramps)

Intersection ID: 42741	Main Street: DANIEL_PLACE_DR	Cross Street: MACANTHRA_DR	Location: NE
ADA ID: 976F1F4D6611	Ramp Type: BlendTrans2	Initial Pass/Fail: Fail	Overall Compliance: No
Severity Score: 8.75			
Codes/Mitigation Info/Possible Solution		Field Measurements/Component Compliance

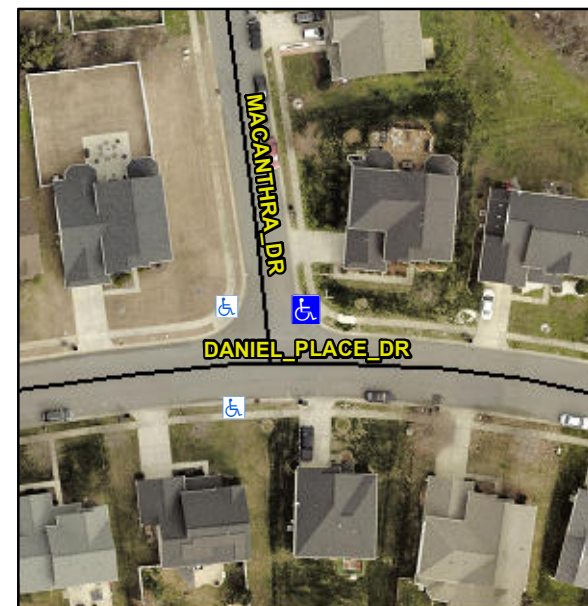
Not Found, R304.5.1

Compliance	Description	Data	Compliance	Description	Data
N/A	Ramp Length (in)	49.0	Yes	BlendTrans Slope (%)	1.4
No	Ramp Width (in)	40.0	Yes	BlendTrans XSlope (%)	1.3
N/A	Flare Type LT	N/A	N/A	Flare Type RT	N/A
N/A	Flare Slope LT (%)	N/A	N/A	Flare Slope RT (%)	N/A
N/A	Flare Traversable LT?	N/A	N/A	Flare Traversable RT?	N/A
N/A	Landing Length (in)	N/A	N/A	DWS Provided?	N/A
N/A	Landing Width (in)	N/A	N/A	DWS Contrast?	N/A
N/A	Landing Slope (%)	N/A	N/A	DWS Length (in)	N/A
N/A	Landing X Slope (%)	N/A	N/A	DWS Full Width?	N/A
N/A	Landing Curb? (Y/N)	N/A	N/A	DWS Offset (in)	N/A
N/A	Shared Landing?	N/A			
N/A	Gutter Ponding?	N/A	N/A	Gutter Slope (%)	N/A
N/A	Gutter Lip Ht (in)	N/A	N/A	Gutter X Slope (%)	N/A
N/A	Painted X Walk1?	No	N/A	Painted X Walk2?	No
	X Walk 1 Direction	To W		X Walk 2 Direction	To S
	X Walk 1 Width (in)	N/A		X Walk 2 Width (in)	N/A
	X Walk 1 Slope (%)	5.4		X Walk 2 Slope (%)	4.3
	X Walk 1 X Slope (%)	0.9		X Walk 2 X Slope (%)	4.3

N/A	Ramp inside XWalk1?	N/A	N/A	Ramp inside XWalk2?	N/A
	Road Slope (%)	3.3		Clear Space?	N/A
	Road X Slope (%)	5.5	N/A	Clear Space to XWalk (in)	N/A
N/A	Any Obstructions?	N/A	N/A	Storm Grate/Utility Hazard?	N/A
	Obstruction Type			Storm Grate/Utility Type	
		N/A			N/A
			Yes	Surface Condition? (G/P)	Good
			No	Curb Slope (%)	21.0

Remove & Replace Curb Ramp With Two New Directional Ramps or Equivalent.
