Access Compliance Report

(Curb Ramps)

Intersection ID: 20587	Main Street: COLONY_RD	Cross Street: FAIRVIEW_RD	Location: SW
ADA ID: 9770B0FE48AB	Ramp Type: Perp	Initial Pass/Fail: Fail	Overall Compliance: No
		Severity Score: 12.5

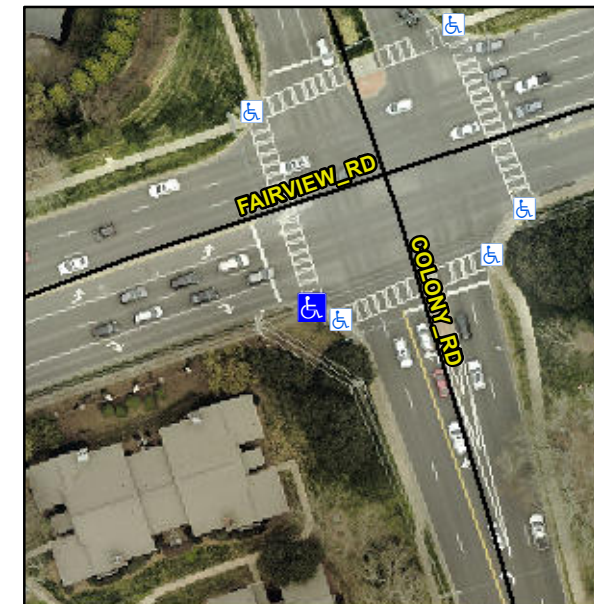
Not Found, R304.5.3

Compliance	Description	Data	Compliance	Description	Data
N/A	Ramp Length (in)	60.0	Yes	Ramp Slope (%)	5.6
Yes	Ramp Width (in)	48.0	No	Ramp XSlope (%)	5.3
N/A	Flare Type LT	N/A	N/A	Flare Type RT	N/A
N/A	Flare Slope LT (%)	N/A	N/A	Flare Slope RT (%)	N/A
N/A	Flare Traversable LT?	N/A	N/A	Flare Traversable RT?	N/A
N/A	Landing Length (in)	N/A	N/A	DWS Provided?	N/A
N/A	Landing Width (in)	N/A	N/A	DWS Contrast?	N/A
N/A	Landing Slope (%)	N/A	N/A	DWS Length (in)	N/A
N/A	Landing X Slope (%)	N/A	N/A	DWS Full Width?	N/A
N/A	Landing Curb? (Y/N)	N/A	N/A	DWS Offset (in)	N/A
N/A	Shared Landing?	N/A			
N/A	Gutter Ponding?	N/A	N/A	Gutter Slope (%)	N/A
N/A	Gutter Lip Ht (in)	N/A	N/A	Gutter X Slope (%)	N/A
N/A	Painted X Walk1?	Yes	N/A	Painted X Walk2?	N/A
	X Walk 1 Direction	To NW		X Walk 2 Direction	N/A
N/A	X Walk 1 Width (in)	109.0	N/A	X Walk 2 Width (in)	N/A
	X Walk 1 Slope (%)	0.6		X Walk 2 Slope (%)	N/A
	X Walk 1 X Slope (%)	2.0		X Walk 2 X Slope (%)	N/A

N/A	Ramp inside XWalk1?	Yes	N/A	Ramp inside XWalk2?	N/A
	Road Slope (%)	N/A	N/A	Clear Space?	N/A
	Road X Slope (%)	N/A	N/A	Clear Space to XWalk (in)	N/A
N/A	Any Obstructions?	N/A	N/A	Storm Grate/Utility Hazard?	N/A
	Obstruction Type			Storm Grate/Utility Type	
		N/A			N/A
			Yes	Surface Condition? (G/P)	Good

Remove & Replace Entire Ramp.

Total Cost: \$ 1850.00
