# Access Compliance Report

## Public Rights-of-Way

### (Curb Ramps)

Intersection ID: 50613	Main Street: BALSAM_BAY_RD	Cross Street: DOWNY_BIRCH_RD	Location: S
ADA ID: 9770DE52D1BA	Ramp Type: Perp	Initial Pass/Fail: Fail	Overall Compliance: No
Severity Score: 22.5			
Codes/Mitigation Info/Possible Solution		Field Measurements/Component Compliance

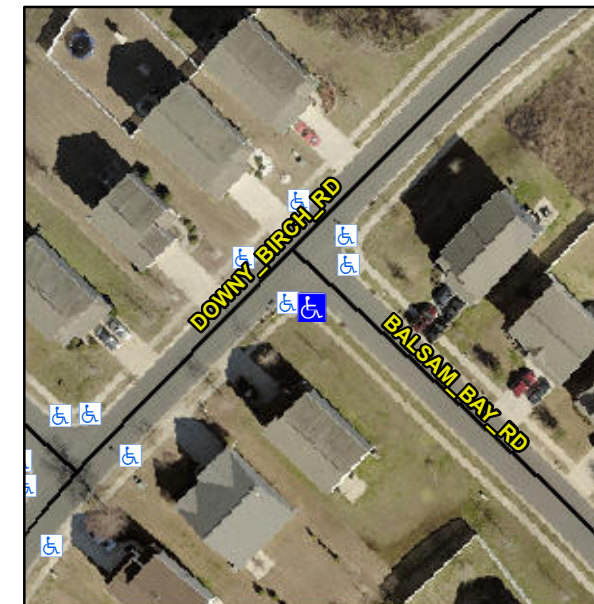
**Not Found, R304.5.1, R304.2.2, R304.5.3**

Compliance	Description	Data	Compliance	Description	Data
N/A	Ramp Length (in)	46.0	No	Ramp Slope (%)	8.4
No	Ramp Width (in)	42.0	No	Ramp XSlope (%)	2.2
N/A	Flare Type LT	N/A	N/A	Flare Type RT	N/A
N/A	Flare Slope LT (%)	N/A	N/A	Flare Slope RT (%)	N/A
N/A	Flare Traversable LT?	N/A	N/A	Flare Traversable RT?	N/A
N/A	Landing Length (in)	N/A	N/A	DWS Provided?	N/A
N/A	Landing Width (in)	N/A	N/A	DWS Contrast?	N/A
N/A	Landing Slope (%)	N/A	N/A	DWS Length (in)	N/A
N/A	Landing X Slope (%)	N/A	N/A	DWS Full Width?	N/A
N/A	Landing Curb? (Y/N)	N/A	N/A	DWS Offset (in)	N/A
N/A	Shared Landing?	N/A			
N/A	Gutter Ponding?	N/A	N/A	Gutter Slope (%)	N/A
N/A	Gutter Lip Ht (in)	N/A	N/A	Gutter X Slope (%)	N/A
N/A	Painted X Walk1?	No	N/A	Painted X Walk2?	N/A
	X Walk 1 Direction	To SE		X Walk 2 Direction	N/A
N/A	X Walk 1 Width (in)	N/A	N/A	X Walk 2 Width (in)	N/A
	X Walk 1 Slope (%)	3.3		X Walk 2 Slope (%)	N/A
	X Walk 1 X Slope (%)	0.4		X Walk 2 X Slope (%)	N/A

N/A	Ramp inside XWalk1?	N/A	N/A	Ramp inside XWalk2?	N/A
	Road Slope (%)	N/A	N/A	Clear Space?	N/A
	Road X Slope (%)	N/A	N/A	Clear Space to XWalk (in)	N/A
N/A	Any Obstructions?	N/A	N/A	Storm Grate/Utility Hazard?	N/A
	Obstruction Type			Storm Grate/Utility Type	
		N/A			N/A
			Yes	Surface Condition? (G/P)	Good

**Remove & Replace Entire Ramp.**

Total Cost: \$ 1850.00
