Access Compliance Report

Public Rights-of-Way

(Curb Ramps)

Intersection ID: 10033071	Main Street: NORTH_COMMUNITY_HOUSE_RD	Cross Street: N/A	Location: S
ADA ID: 977638BD7D83	Ramp Type: Para	Initial Pass/Fail: Fail	Overall Compliance: No
		Severity Score: 12.5	
Codes/Mitigation Info/Possible Solution		Field Measurements/Component Compliance

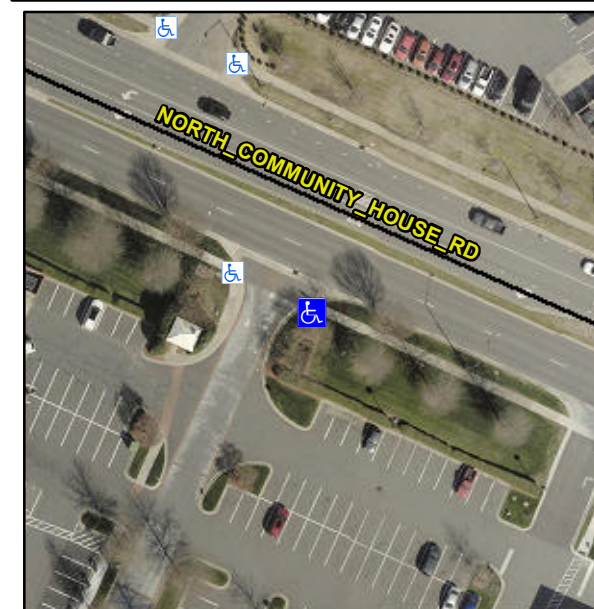
Compliance	Description	Data	Compliance	Description	Data
N/A	Ramp Length LT (in)	28.0	N/A	Ramp Length RT (in)	62.0
Yes	Ramp Width LT (in)	84.0	Yes	Ramp Width RT (in)	75.0
Yes	Ramp Slope LT (%)	7.7	No	Ramp Slope RT (%)	11.1
Yes	Ramp XSlope LT (%)	1.1	Yes	Ramp XSlope RT (%)	1.4
N/A	Landing Length (in)	N/A	N/A	DWS Provided?	N/A
N/A	Landing Width (in)	N/A	N/A	DWS Contrast?	N/A
N/A	Landing Slope (%)	N/A	N/A	DWS Length (in)	N/A
N/A	Landing X Slope (%)	N/A	N/A	DWS Full Width?	N/A
N/A	Landing Curb? (Y/N)	N/A	N/A	DWS Offset (in)	N/A
N/A	Shared Landing?	N/A			
N/A	Gutter Ponding?	N/A	N/A	Gutter Slope (%)	N/A
N/A	Gutter Lip Ht (in)	N/A	N/A	Gutter X Slope (%)	N/A
N/A	Painted X Walk1?	No	N/A	Painted X Walk2?	N/A
	X Walk 1 Direction	To NW		X Walk 2 Direction	N/A
N/A	X Walk 1 Width (in)	N/A	N/A	X Walk 2 Width (in)	N/A
	X Walk 1 Slope (%)	0.0		X Walk 2 Slope (%)	N/A
	X Walk 1 X Slope (%)	2.3		X Walk 2 X Slope (%)	N/A
N/A	Ramp inside XWalk1?	N/A	N/A	Ramp inside XWalk2?	N/A

Road Slope (%)	N/A	N/A	Clear Space?	N/A
	Road X Slope (%)	N/A	N/A	Clear Space to XWalk (in)	N/A
N/A	Any Obstructions?	N/A	N/A	Storm Grate/Utility Hazard?	N/A
	Obstruction Type			Storm Grate/Utility Type	
		N/A			N/A
			Yes	Surface Condition? (G/P)	Good
			N/A	Curb Slope (%)	10.8

Possible Solutions:

Remove & Replace Entire Ramp.

R304.3.2
