# Access Compliance Report

## Public Rights-of-Way

| Intersection ID: 14621 | Main Street: KENMORE_AV | Cross Street: N_LAUREL_AV | Location: W |
| ADA ID: 9777D730A1FE | Ramp Type: PerpDiag | Initial Pass/Fail: Fail | Overall Compliance: No |

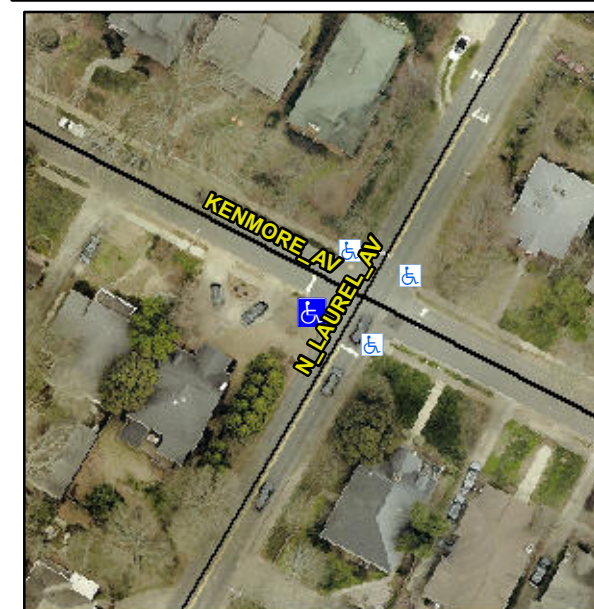
**R304.2.2, R304.5.3**

| Compliance | Description | Data | Compliance | Description | Data |
|---|---|---|---|---|---|
| N/A | Ramp Length (in) | 65.0 | No | Ramp Slope (%) | 9.2 |
| Yes | Ramp Width (in) | 48.0 | No | Ramp XSlope (%) | 3.1 |

**Remove & Replace Curb Ramp With Two New Directional Ramps or Equivalent.**

Total Cost: \$ 3200.00

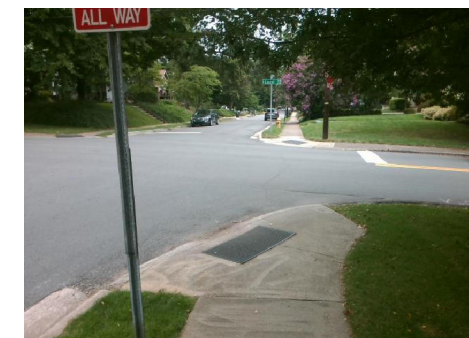
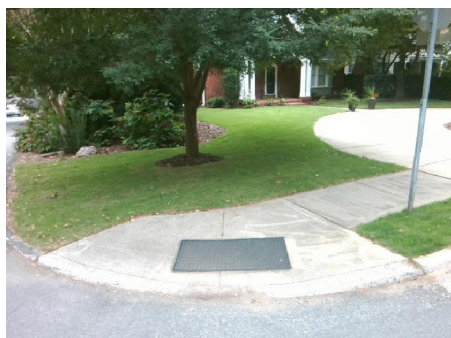
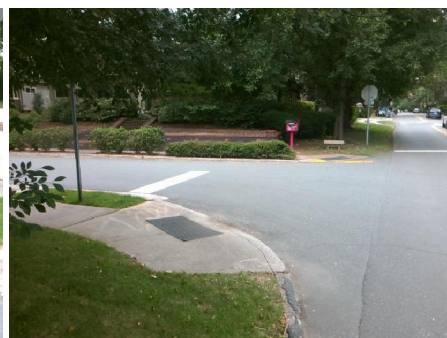
Street 1 Name N LAUREL AV  
 Stop Condition-Street 2 StopSign  
 Street 2 Name KENMORE AV  
 Stop Condition-Street 1 StopSign
