# Access Compliance Report

## Public Rights-of-Way

### (Curb Ramps)

Intersection ID: N/A	Main Street: GREEN_REA_RD	Cross Street: OCKLEY_MANOR_LN	Location: SW
ADA ID: 977DE01E5B4A	Ramp Type: PerpDiag	Initial Pass/Fail: Fail	Overall Compliance: No
Codes/Mitigation Info/Possible Solution		Field Measurements/Component Compliance

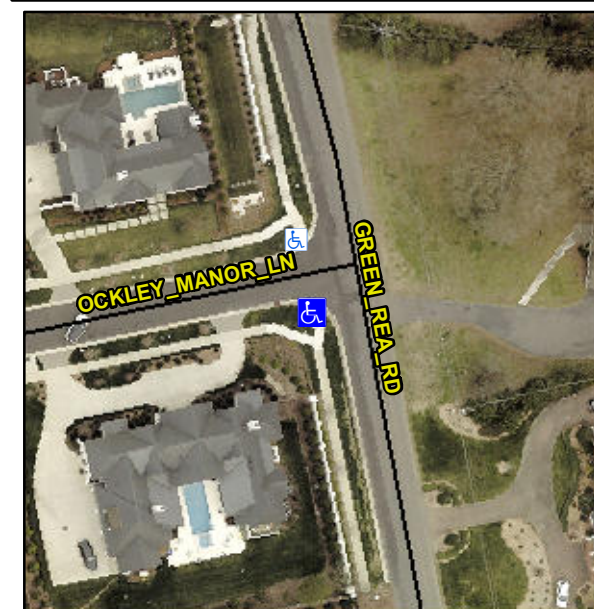
**Not Found, R304.2.2, R304.5.3**

Compliance	Description	Data	Compliance	Description	Data
N/A	Ramp Length (in)	84.0	No	Ramp Slope (%)	9.0
Yes	Ramp Width (in)	62.0	No	Ramp XSlope (%)	4.2
N/A	Flare Type LT	N/A	N/A	Flare Type RT	N/A
N/A	Flare Slope LT (%)	N/A	N/A	Flare Slope RT (%)	N/A
N/A	Flare Traversable LT?	N/A	N/A	Flare Traversable RT?	N/A
N/A	Landing Length (in)	N/A	N/A	DWS Provided?	N/A
N/A	Landing Width (in)	N/A	N/A	DWS Contrast?	N/A
N/A	Landing Slope (%)	N/A	N/A	DWS Length (in)	N/A
N/A	Landing X Slope (%)	N/A	N/A	DWS Full Width?	N/A
N/A	Landing Curb? (Y/N)	N/A	N/A	DWS Offset (in)	N/A
N/A	Shared Landing?	N/A			
N/A	Gutter Ponding?	N/A	N/A	Gutter Slope (%)	N/A
N/A	Gutter Lip Ht (in)	1.5	N/A	Gutter X Slope (%)	N/A
N/A	Painted X Walk1?	No	N/A	Painted X Walk2?	No
	X Walk 1 Direction	To E		X Walk 2 Direction	To N
N/A	X Walk 1 Width (in)	N/A	N/A	X Walk 2 Width (in)	N/A
	X Walk 1 Slope (%)	1.5		X Walk 2 Slope (%)	1.1
	X Walk 1 X Slope (%)	0.5		X Walk 2 X Slope (%)	1.8

N/A	Ramp inside XWalk1?	N/A	N/A	Ramp inside XWalk2?	N/A
	Road Slope (%)	1.1	N/A	Clear Space?	N/A
	Road X Slope (%)	0.3	N/A	Clear Space to XWalk (in)	N/A
N/A	Any Obstructions?	N/A	N/A	Storm Grate/Utility Hazard?	N/A
	Obstruction Type			Storm Grate/Utility Type	
		N/A			N/A
		Yes		Surface Condition? (G/P)	Good

**Remove & Replace Curb Ramp With Two New Directional Ramps or Equivalent.**
