Access Compliance Report

Public Rights-of-Way

(Curb Ramps)

Intersection ID: 24503	Main Street: BRUFF_CT	Cross Street: SAINTFIELD_PL	Location: SW
ADA ID: 977DFDA42194	Ramp Type: Perp	Initial Pass/Fail: Fail	Overall Compliance: No
Codes/Mitigation Info/Possible Solution		Field Measurements/Component Compliance	
Severity Score: 10

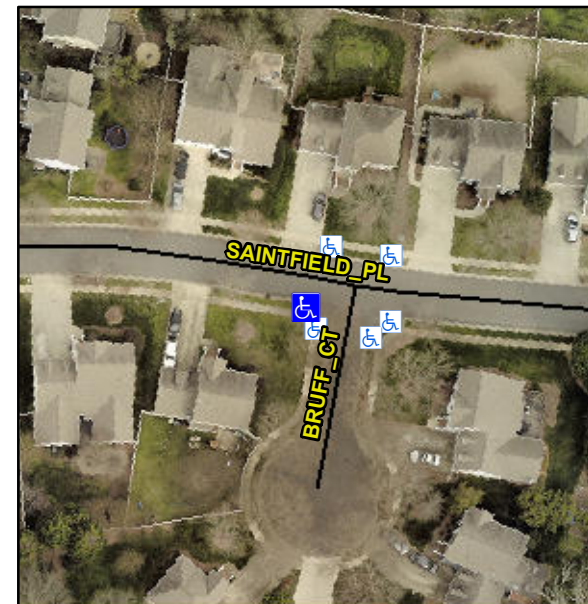
Not Found, R304.5.1, R304.5.3

Compliance	Description	Data	Compliance	Description	Data
N/A	Ramp Length (in)	46.0	Yes	Ramp Slope (%)	7.3
No	Ramp Width (in)	36.0	No	Ramp XSlope (%)	3.3
N/A	Flare Type LT	N/A	N/A	Flare Type RT	N/A
N/A	Flare Slope LT (%)	N/A	N/A	Flare Slope RT (%)	N/A
N/A	Flare Traversable LT?	N/A	N/A	Flare Traversable RT?	N/A
N/A	Landing Length (in)	N/A	N/A	DWS Provided?	N/A
N/A	Landing Width (in)	N/A	N/A	DWS Contrast?	N/A
N/A	Landing Slope (%)	N/A	N/A	DWS Length (in)	N/A
N/A	Landing X Slope (%)	N/A	N/A	DWS Full Width?	N/A
N/A	Landing Curb? (Y/N)	N/A	N/A	DWS Offset (in)	N/A
N/A	Shared Landing?	N/A			
N/A	Gutter Ponding?	N/A	N/A	Gutter Slope (%)	N/A
N/A	Gutter Lip Ht (in)	N/A	N/A	Gutter X Slope (%)	N/A
N/A	Painted X Walk1?	No	N/A	Painted X Walk2?	N/A
	X Walk 1 Direction	To N		X Walk 2 Direction	N/A
N/A	X Walk 1 Width (in)	N/A	N/A	X Walk 2 Width (in)	N/A
	X Walk 1 Slope (%)	0.6		X Walk 2 Slope (%)	N/A
	X Walk 1 X Slope (%)	2.4		X Walk 2 X Slope (%)	N/A

N/A	Ramp inside XWalk1?	N/A	N/A	Ramp inside XWalk2?	N/A
	Road Slope (%)	N/A	N/A	Clear Space?	N/A
	Road X Slope (%)	N/A	N/A	Clear Space to XWalk (in)	N/A
N/A	Any Obstructions?	N/A	N/A	Storm Grate/Utility Hazard?	N/A
	Obstruction Type			Storm Grate/Utility Type	
		N/A			N/A
			Yes	Surface Condition? (G/P)	Good

Possible Solutions:

Remove & Replace Entire Ramp.
