Access Compliance Report Public Rights-of-Way (Curb Ramps)

Intersection ID: 5514Main Street:SUNSET_RDCross Street:MILHAVEN_LNLocation:SWADA ID: 97829C28E8C6Ramp Type:PerpInitial Pass/Fail:PassOverall Compliance:NoSeverity Score:12.5

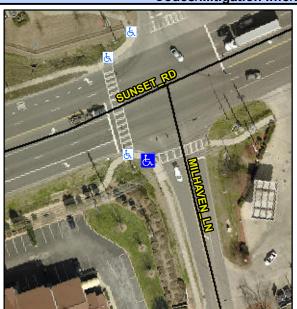
Field Measurements/Component Compliance							
Comp	liance Description	Data	Comp	liance Description	Data		
N/A	Ramp Length (in)	89.0	Yes	Ramp Slope (%)	7.8		
Yes	Ramp Width (in)	54.0	Yes	Ramp XSlope (%)	1.3		
N/A	Flare Type LT	Sloped	N/A	Flare Type RT	N/A		
N/A	Flare Slope LT (%)	6.8	Yes	Flare Slope RT (%)	6.0		
N/A	Flare Traversable LT?	No	N/A	Flare Traversable RT?	Yes		
No	Landing Length (in)	N/A	Yes	DWS Provided?	Yes		
No	Landing Width (in)	N/A	Yes	DWS Contrast?	Yes		
No	Landing Slope (%)	N/A	Yes	DWS Length (in)	24.5		
No	Landing X Slope (%)	N/A	No	DWS Full Width?	No		
N/A	Landing Curb? (Y/N)	No	No	DWS Offset (in)	3.5		
N/A	Shared Landing?	No					
Yes	Gutter Ponding?	No	Yes	Gutter Slope (%)	3.8		
Yes	Gutter Lip Ht (in)	0.0	Yes	Gutter X Slope (%)	0.7		
N/A	Painted X Walk1?	No	N/A	Painted X Walk2?	N/A		
	X Walk 1 Direction	То Е		X Walk 2 Direction	N/A		
N/A	X Walk 1 Width (in)	N/A	N/A	X Walk 2 Width (in)	N/A

X Walk 1 Slope (%)	3.6		X Walk 2 Slope (%)	N/A		
	X Walk 1 X Slope (%)	1.1		X Walk 2 X Slope (%)	N/A		
N/A	Ramp inside XWalk1?	N/A	N/A	Ramp inside XWalk2?	N/A		
	Road Slope (%)	N/A	N/A	Clear Space?	Yes		
	Road X Slope (%)	N/A	N/A	Clear Space to XWalk (in)	N/A		
Yes	Any Obstructions?	No	Yes	Storm Grate/Utility Hazard?	No		
	Obstruction Type			Storm Grate/Utility Type			
		N/A			N/A		
			Yes	Surface Condition? (G/P)	Good

Cooldic Colution				
Possible Solutions:				
Remove & Replace Entire Ramp.				
Surveyor Notes:				
N/A				
DDOWADA.				
PROW/ADA:				
Not Found, R304.2.1, R304.2.2-Perp,				
R304.3.2-Para, R304.5.3, R305.1.4, R305.2				
1000.2

Total Cost:	\$ 1850.0
