Access Compliance Report

Public Rights-of-Way

(Curb Ramps)

Intersection ID: 15239	Main Street: HAVERFORD_PL	Cross Street: POINDEXTER_DR	Location: W
ADA ID: 9786BFA18B79	Ramp Type: Directional1	Initial Pass/Fail: Fail	Overall Compliance: No
		Severity Score: 1.25

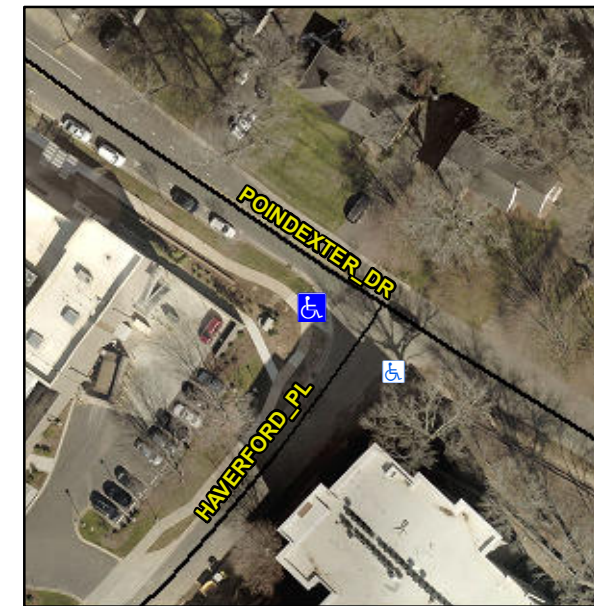
R304.5.3

Compliance	Description	Data	Compliance	Description	Data
N/A	Ramp Length (in)	84.0	N/A	Grade Break?	N/A
Yes	Ramp Width (in)	71.0	N/A	Grade Break Slope (%)	0.0
Yes	Ramp Slope (%)	5.4	N/A	Grade Break XSlope (%)	0.0
No	Ramp XSlope (%)	3.4			
N/A	Flare Type LT	N/A	N/A	Flare Type RT	N/A
N/A	Flare Slope LT (%)	N/A	N/A	Flare Slope RT (%)	0.0
N/A	Flare Traversable LT?	N/A	N/A	Flare Traversable RT?	N/A
N/A	Landing Length (in)	0.0	N/A	DWS Provided?	N/A
N/A	Landing Width (in)	0.0	N/A	DWS Contrast?	N/A
N/A	Landing Slope (%)	0.0	N/A	DWS Length (in)	N/A
N/A	Landing X Slope (%)	0.0	N/A	DWS Full Width?	N/A
N/A	Landing Curb? (Y/N)	N/A	N/A	DWS Offset LT (in)	N/A
N/A	Shared Landing?	N/A	N/A	DWS Offset RT (in)	N/A
N/A	Gutter Ponding?	0.0	N/A	Gutter Slope (%)	N/A
N/A	Gutter Lip Ht (in)	0.0	N/A	Gutter X Slope (%)	N/A
N/A	Painted X Walk1?	No		Road Slope (%)	1.4
	X Walk 1 Direction	To SE		Road X Slope (%)	3.5
	X Walk 1 Width (in)	N/A		Clear Space?	N/A

X Walk 1 Slope (%)	1.4	N/A	Clear Space to XWalk (in)	N/A
	X Walk 1 X Slope (%)	3.5	N/A	Storm Grate/Utility Hazard?	N/A
N/A	Ramp inside XWalk1?	N/A		Storm Grate/Utility Type	
N/A	Any Obstructions?	N/A			N/A
	Obstruction Type		Yes	Surface Condition? (G/P)	Good
			N/A	Curb Slope (%)	8.9

Remove & Replace Entire Ramp.

Total Cost: \$ 1600.00
