Access Compliance Report

Public Rights-of-Way

(Curb Ramps)

| Intersection ID: 7025 | Main Street: HUTCHISON-MCDONALD_RD | Cross Street: STATESVILLE_RD | Location: SW |

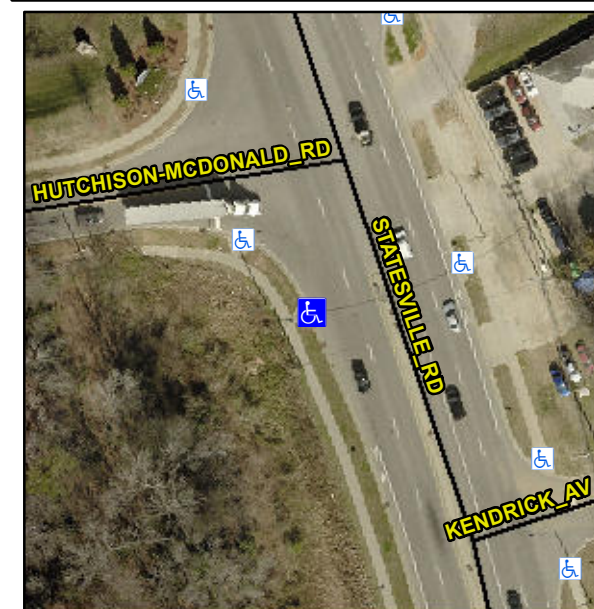
| ADA ID: 97889271FABE | Ramp Type: Perp | Initial Pass/Fail: Fail | Overall Compliance: No |
| | | Severity Score: 8.75 | |

Not Found, R304.5.1

| Compliance | Description | Data | Compliance | Description | Data |
|---|---|---|---|---|---|
| No | Ramp Width (in) | 47.0 | Yes | Ramp XSlope (%) | 1.5 |

Remove & Replace Entire Ramp.
