# Access Compliance Report

### (Curb Ramps)

| Intersection ID: 13760 | Main Street: EUCLID_AV | Cross Street: TEMPLETON_AV | Location: E |
| ADA ID: 978BEC9F95B4 | Ramp Type: Directional1 | Initial Pass/Fail: Fail | Overall Compliance: No |

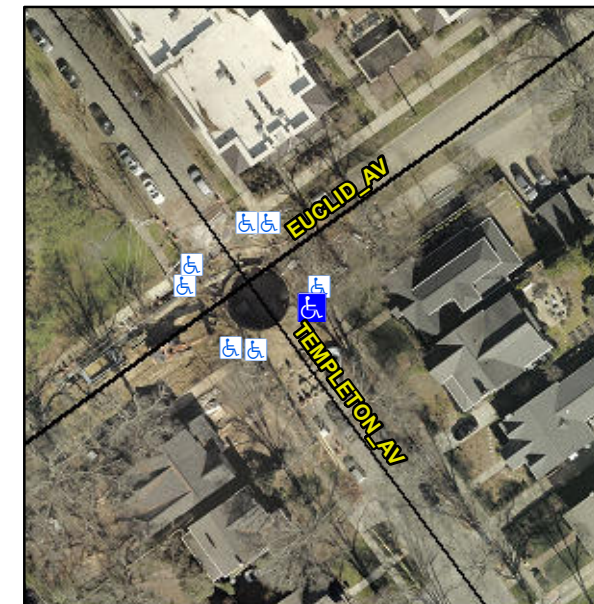
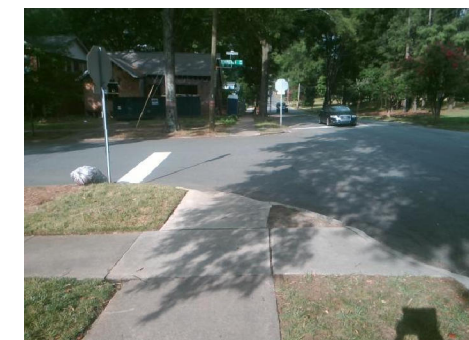
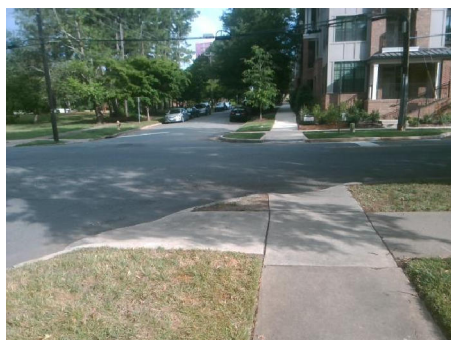
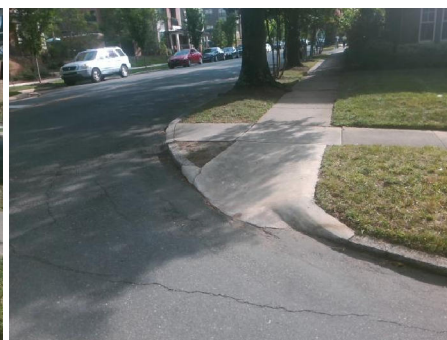
| | | Severity Score: 22.5 | |

**R304.5.1, R304.2.2, R304.5.3**

| Compliance | Description | Data | Compliance | Description | Data |
|---|---|---|---|---|---|
| No | Ramp Width (in) | 36.0 | N/A | Grade Break Slope (%) | 0.0 |
| No | Ramp Slope (%) | 11.8 | N/A | Grade Break XSlope (%) | 0.0 |
| No | Ramp XSlope (%) | 4.2 | | | |

**Remove & Replace Entire Ramp.**
