# Access Compliance Report

## Public Rights-of-Way

### (Curb Ramps)

Intersection ID: 7900	Main Street: EDGERTON_DR	Cross Street: SNOW_WHITE_LN	Location: SE
ADA ID: 978C309DCF9F	Ramp Type: Perp	Initial Pass/Fail: Fail	Overall Compliance: No
Severity Score: 12.5			
Codes/Mitigation Info/Possible Solution		Field Measurements/Component Compliance

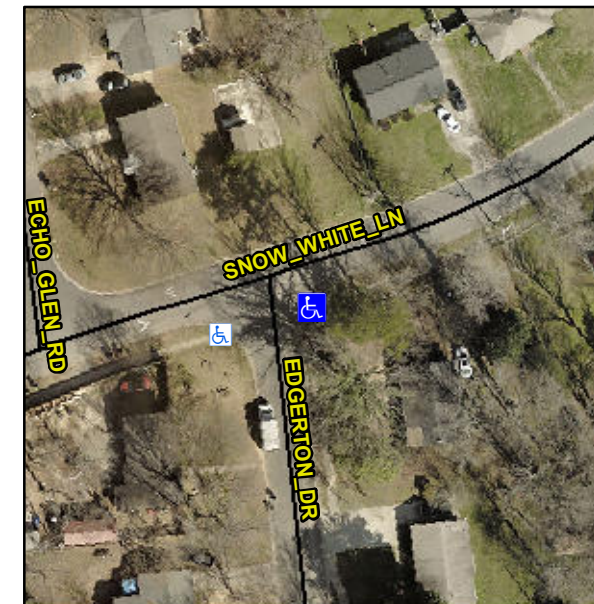
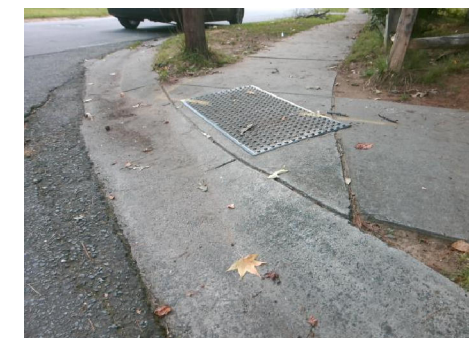
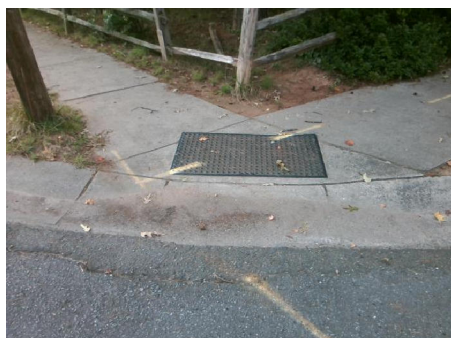
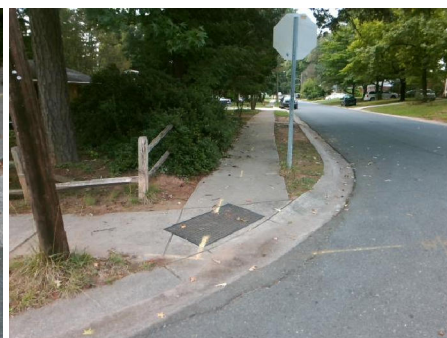
**Not Found, R304.2.2**

Compliance	Description	Data	Compliance	Description	Data
N/A	Ramp Length (in)	20.5	No	Ramp Slope (%)	9.7
Yes	Ramp Width (in)	48.0	Yes	Ramp XSlope (%)	2.0
N/A	Flare Type LT	N/A	N/A	Flare Type RT	N/A
N/A	Flare Slope LT (%)	N/A	N/A	Flare Slope RT (%)	N/A
N/A	Flare Traversable LT?	N/A	N/A	Flare Traversable RT?	N/A
N/A	Landing Length (in)	N/A	N/A	DWS Provided?	N/A
N/A	Landing Width (in)	N/A	N/A	DWS Contrast?	N/A
N/A	Landing Slope (%)	N/A	N/A	DWS Length (in)	N/A
N/A	Landing X Slope (%)	N/A	N/A	DWS Full Width?	N/A
N/A	Landing Curb? (Y/N)	N/A	N/A	DWS Offset (in)	N/A
N/A	Shared Landing?	N/A			
N/A	Gutter Ponding?	Yes	N/A	Gutter Slope (%)	N/A
N/A	Gutter Lip Ht (in)	N/A	N/A	Gutter X Slope (%)	N/A
N/A	Painted X Walk1?	No	N/A	Painted X Walk2?	N/A
	X Walk 1 Direction	To W		X Walk 2 Direction	N/A
N/A	X Walk 1 Width (in)	N/A	N/A	X Walk 2 Width (in)	N/A
	X Walk 1 Slope (%)	3.8		X Walk 2 Slope (%)	N/A
	X Walk 1 X Slope (%)	2.8		X Walk 2 X Slope (%)	N/A

N/A	Ramp inside XWalk1?	N/A	N/A	Ramp inside XWalk2?	N/A
	Road Slope (%)	N/A	N/A	Clear Space?	N/A
	Road X Slope (%)	N/A	N/A	Clear Space to XWalk (in)	N/A
N/A	Any Obstructions?	N/A	N/A	Storm Grate/Utility Hazard?	N/A
	Obstruction Type			Storm Grate/Utility Type	
		N/A			N/A
		Yes		Surface Condition? (G/P)	Good

**Remove & Replace Entire Ramp.**

Total Cost: \$ 1850.00
