# Access Compliance Report

## Public Rights-of-Way

| Intersection ID: 47087 | Main Street: MARVIN_RD | Cross Street: COVENTRY_COURT_LN | Location: NE |
| ADA ID: 978F3F0EABA5 | Ramp Type: PerpDiag | Initial Pass/Fail: Fail | Overall Compliance: No |

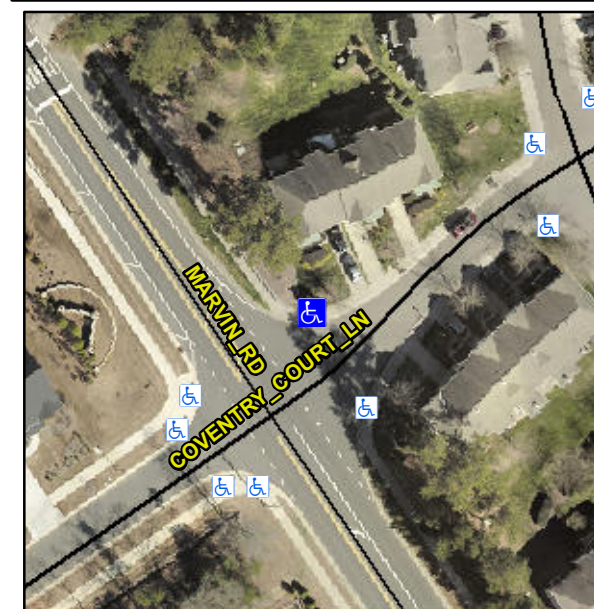
| Severity Score: 13.75 | | | |

**R304.2.2, R304.5.3**

| Compliance | Description | Data | Compliance | Description | Data |
|---|---|---|---|---|---|
| N/A | Ramp Length (in) | 57.0 | No | Ramp Slope (%) | 8.7 |
| Yes | Ramp Width (in) | 48.0 | No | Ramp XSlope (%) | 3.8 |

**Remove & Replace Curb Ramp With Two New Directional Ramps or Equivalent.**

Total Cost: \$ 3200.00
