Access Compliance Report

Public Rights-of-Way

(Curb Ramps)

Intersection ID: 45285	Main Street: MOSS LAKE RD	Cross Street: VALLEY RIDGE RD	Location: W
ADA ID: 9793FF3AC4EA	Ramp Type: PerpDiag	Initial Pass/Fail: Fail	Overall Compliance: No
Codes/Mitigation Info/Possible Solution		Field Measurements/Component Compliance	
Severity Score: 17.5

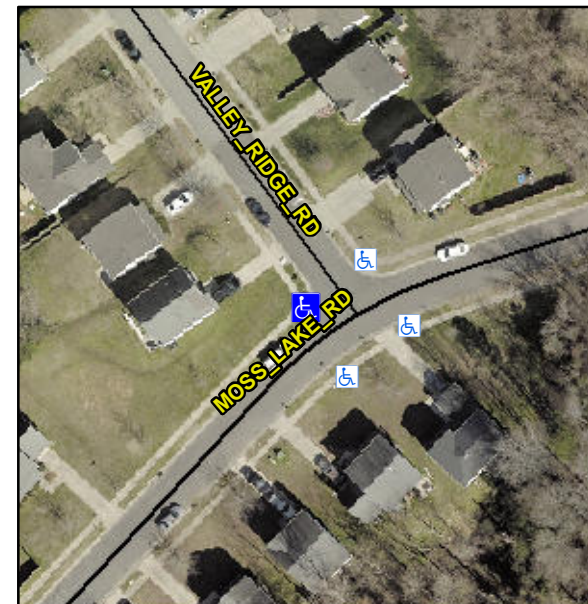
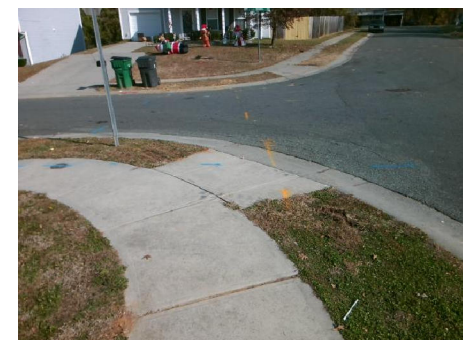
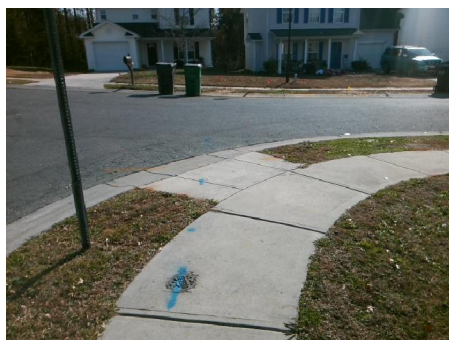
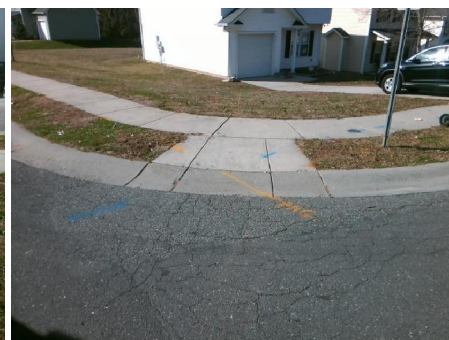
Not Found, R304.5.1

Compliance	Description	Data	Compliance	Description	Data
N/A	Ramp Length (in)	48.0	Yes	Ramp Slope (%)	6.1
No	Ramp Width (in)	35.0	Yes	Ramp XSlope (%)	1.0
N/A	Flare Type LT	N/A	N/A	Flare Type RT	N/A
N/A	Flare Slope LT (%)	N/A	N/A	Flare Slope RT (%)	N/A
N/A	Flare Traversable LT?	N/A	N/A	Flare Traversable RT?	N/A
N/A	Landing Length (in)	N/A	N/A	DWS Provided?	N/A
N/A	Landing Width (in)	N/A	N/A	DWS Contrast?	N/A
N/A	Landing Slope (%)	N/A	N/A	DWS Length (in)	N/A
N/A	Landing X Slope (%)	N/A	N/A	DWS Full Width?	N/A
N/A	Landing Curb? (Y/N)	N/A	N/A	DWS Offset (in)	N/A
N/A	Shared Landing?	N/A			
N/A	Gutter Ponding?	N/A	N/A	Gutter Slope (%)	N/A
N/A	Gutter Lip Ht (in)	N/A	N/A	Gutter X Slope (%)	N/A
N/A	Painted X Walk1?	No	N/A	Painted X Walk2?	No
	X Walk 1 Direction	To SE		X Walk 2 Direction	To NE
N/A	X Walk 1 Width (in)	N/A	N/A	X Walk 2 Width (in)	N/A
	X Walk 1 Slope (%)	6.0		X Walk 2 Slope (%)	4.6
	X Walk 1 X Slope (%)	2.8		X Walk 2 X Slope (%)	3.6

N/A	Ramp inside XWalk1?	N/A	N/A	Ramp inside XWalk2?	N/A
	Road Slope (%)	0.5	N/A	Clear Space?	N/A
	Road X Slope (%)	3.3	N/A	Clear Space to XWalk (in)	N/A
N/A	Any Obstructions?	N/A	N/A	Storm Grate/Utility Hazard?	N/A
	Obstruction Type			Storm Grate/Utility Type	
		N/A			N/A
			Yes	Surface Condition? (G/P)	Good

Remove & Replace Curb Ramp With Two New Directional Ramps or Equivalent.

Total Cost: \$ **3200.00**
