# Access Compliance Report

## Public Rights-of-Way

### (Curb Ramps)

| Intersection ID: 13476 | Main Street: ELIZABETH_AV | Cross Street: PEASE_LN | Location: E |

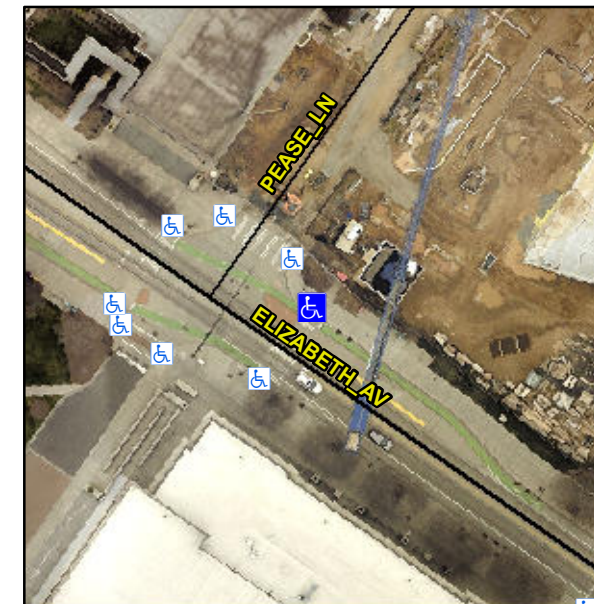
**Not Found, R304.5.3, R304.2.1**

| Compliance | Description | Data | Compliance | Description | Data |
|---|---|---|---|---|---|
| Yes | Ramp Width (in) | 48.0 | No | Ramp XSlope (%) | 3.8 |
| No | Landing Length (in) | 44.5 | Yes | DWS Provided? | Yes |
| No | Landing X Slope (%) | 3.6 | Yes | DWS Full Width? | Yes |
| Yes | Gutter Lip Ht (in) | 0.0 | No | Gutter X Slope (%) | 3.5 |

**Remove & Replace Entire Ramp.  
Remove & Replace Gutter.**

Total Cost: \$ 2600.00
