Access Compliance Report

Public Rights-of-Way

(Curb Ramps)

Intersection ID: 29713	Main Street: COLE_MILL_RD	Cross Street: ROBESON_CREEK_DR	Location: S
ADA ID: 979F764EA5EC	Ramp Type: BlendTrans1	Initial Pass/Fail: Fail	Overall Compliance: No
Severity Score: 8.75			
Codes/Mitigation Info/Possible Solution		Field Measurements/Component Compliance

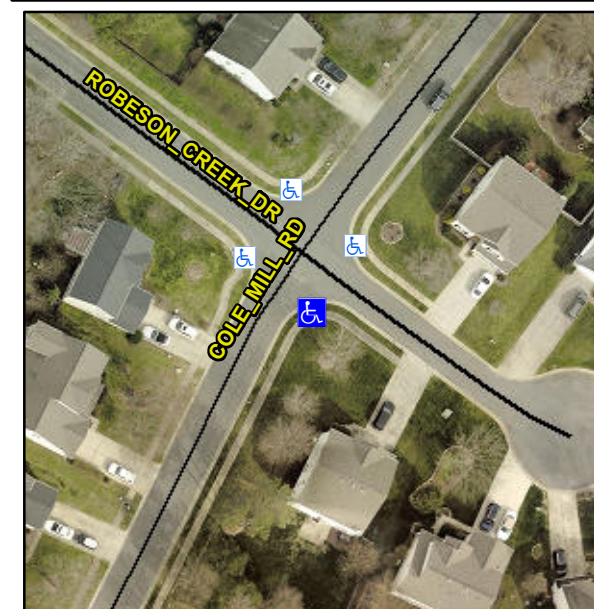
Compliance	Description	Data	Compliance	Description	Data
N/A	Ramp Length (in)	45.0	Yes	BlendTrans Slope (%)	1.2
No	Ramp Width (in)	47.0	Yes	BlendTrans XSlope (%)	1.8
N/A	Flare Type LT	N/A	N/A	Flare Type RT	N/A
N/A	Flare Slope LT (%)	N/A	N/A	Flare Slope RT (%)	N/A
N/A	Flare Traversable LT?	N/A	N/A	Flare Traversable RT?	N/A
N/A	Landing Length (in)	N/A	N/A	DWS Provided?	N/A
N/A	Landing Width (in)	N/A	N/A	DWS Contrast?	N/A
N/A	Landing Slope (%)	N/A	N/A	DWS Length (in)	N/A
N/A	Landing X Slope (%)	N/A	N/A	DWS Full Width?	N/A
N/A	Landing Curb? (Y/N)	N/A	N/A	DWS Offset (in)	N/A
N/A	Shared Landing?	N/A			
N/A	Gutter Ponding?	N/A	N/A	Gutter Slope (%)	N/A
N/A	Gutter Lip Ht (in)	N/A	N/A	Gutter X Slope (%)	N/A
N/A	Painted X Walk1?	No	N/A	Painted X Walk2?	No
	X Walk 1 Direction	To NE		X Walk 2 Direction	To NW
	X Walk 1 Width (in)	N/A		X Walk 2 Width (in)	N/A
	X Walk 1 Slope (%)	6.5		X Walk 2 Slope (%)	2.5
	X Walk 1 X Slope (%)	0.5		X Walk 2 X Slope (%)	4.8

N/A	Ramp inside XWalk1?	N/A	N/A	Ramp inside XWalk2?	N/A
	Road Slope (%)	3.0		Clear Space?	N/A
	Road X Slope (%)	3.7	N/A	Clear Space to XWalk (in)	N/A
N/A	Any Obstructions?	N/A	N/A	Storm Grate/Utility Hazard?	N/A
	Obstruction Type			Storm Grate/Utility Type	
		N/A			N/A
			Yes	Surface Condition? (G/P)	Good
			N/A	Curb Slope (%)	2.3

Possible Solutions:

Remove & Replace Curb Ramp With Two New Directional Ramps or Equivalent.

R304.5.1

Total Cost: \$ 3200.00
