Access Compliance Report Public Rights-of-Way (Curb Ramps)

Intersection ID: 13684 Main Street: BAY_ST Cross Street: PECAN_AV Location: N

ADA ID: 97A7ABDB457A Ramp Type: BlendTrans2 Initial Pass/Fail: Fail Overall Compliance: No Severity Score: 8.75

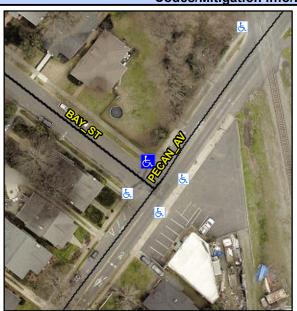
GTR GAP 1.0

Not Found, R304.5.1

Field Measurements/Component Compnance					
Compliance Description		Data	Comp	liance Description	Data
N/A	Ramp Length (in)	98.0	Yes	BlendTrans Slope (%)	4.0
No	Ramp Width (in)	47.0	Yes	BlendTrans XSlope (%)	1.3
N/A	Flare Type LT	N/A	N/A	Flare Type RT	N/A
N/A	Flare Slope LT (%)	N/A	N/A	Flare Slope RT (%)	N/A
N/A	Flare Traversable LT?	N/A	N/A	Flare Traversable RT?	N/A
N/A	Landing Length (in)	N/A	N/A	DWS Provided?	N/A
N/A	Landing Width (in)	N/A	N/A	DWS Contrast?	N/A
N/A	Landing Slope (%)	N/A	N/A	DWS Length (in)	N/A
N/A	Landing X Slope (%)	N/A	N/A	DWS Full Width?	N/A
N/A	Landing Curb? (Y/N)	N/A	N/A	DWS Offset (in)	N/A
N/A	Shared Landing?	N/A			
N/A	Gutter Ponding?	N/A	N/A	Gutter Slope (%)	N/A
N/A	Gutter Lip Ht (in)	N/A	N/A	Gutter X Slope (%)	N/A
N/A	Painted X Walk1?	No	N/A	Painted X Walk2?	No
	X Walk 1 Direction	To SW		X Walk 2 Direction	To SE
	X Walk 1 Width (in)	N/A		X Walk 2 Width (in)	N/A
	X Walk 1 Slope (%)	4.9		X Walk 2 Slope (%)	3.7

X Walk 1 X Slope (%)	1.6		X Walk 2 X Slope (%)	3.5
N/A	Ramp inside XWalk1?	N/A	N/A	Ramp inside XWalk2?	N/A
	Road Slope (%)	0.3		Clear Space?	N/A
	Road X Slope (%)	9.6	N/A	Clear Space to XWalk (in)	N/A
N/A	Any Obstructions?	N/A	N/A	Storm Grate/Utility Hazard?	N/A

Remove & Replace Curb Ramp With Two New Directional Ramps or Equivalent.

Total Cost: \$ 3200.00
