Access Compliance Report

Public Rights-of-Way

(Curb Ramps)

Intersection ID: 10033070	Main Street: NORTH_COMMUNITY_HOUSE_RD	Cross Street: N/A	Location: NW
ADA ID: 97A9B0717C4F	Ramp Type: Directional	Initial Pass/Fail: Fail	Overall Compliance: No
		Severity Score: 1.25

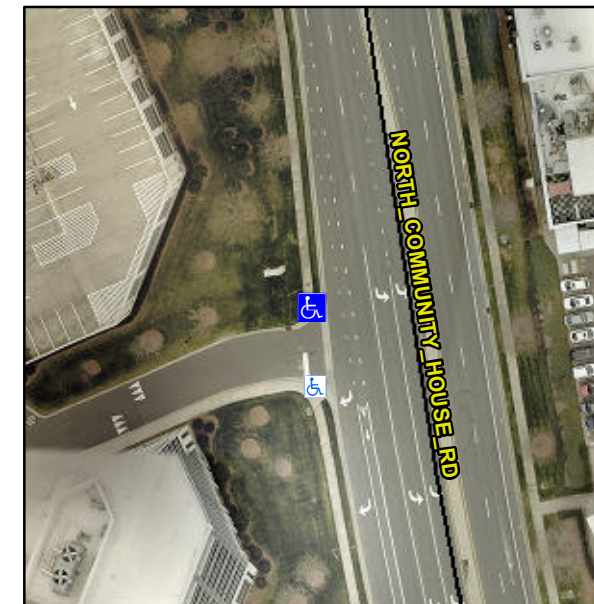
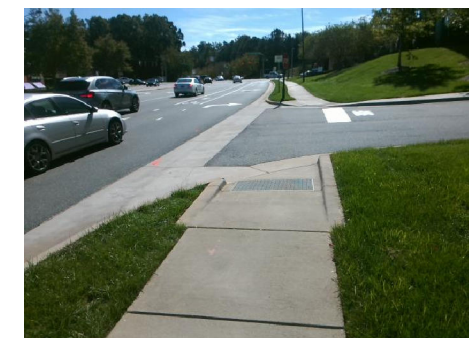
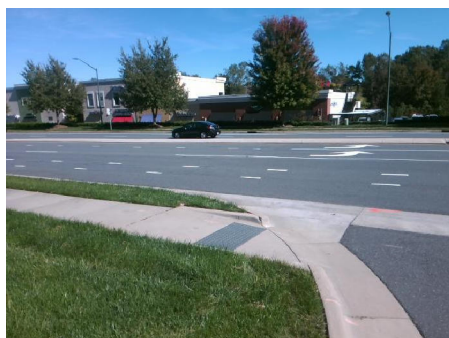
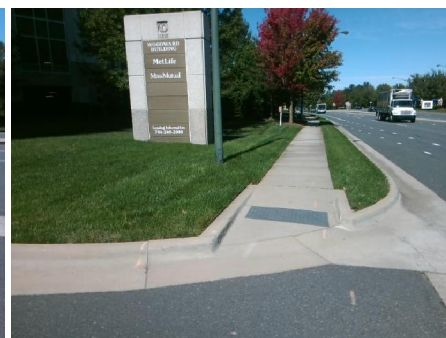
Compliance	Description	Data	Compliance	Description	Data
N/A	Ramp Length (in)	73.0	N/A	Grade Break?	N/A
Yes	Ramp Width (in)	57.0	N/A	Grade Break Slope (%)	0.0
Yes	Ramp Slope (%)	2.0	N/A	Grade Break XSlope (%)	0.0
No	Ramp XSlope (%)	5.0			
N/A	Flare Type LT	N/A	N/A	Flare Type RT	N/A
N/A	Flare Slope LT (%)	N/A	N/A	Flare Slope RT (%)	0.0
N/A	Flare Traversable LT?	N/A	N/A	Flare Traversable RT?	N/A
N/A	Landing Length (in)	0.0	N/A	DWS Provided?	N/A
N/A	Landing Width (in)	0.0	N/A	DWS Contrast?	N/A
N/A	Landing Slope (%)	0.0	N/A	DWS Length (in)	N/A
N/A	Landing X Slope (%)	0.0	N/A	DWS Full Width?	N/A
N/A	Landing Curb? (Y/N)	N/A	N/A	DWS Offset LT (in)	N/A
N/A	Shared Landing?	N/A	N/A	DWS Offset RT (in)	N/A
N/A	Gutter Ponding?	0.0	N/A	Gutter Slope (%)	N/A
N/A	Gutter Lip Ht (in)	0.0	N/A	Gutter X Slope (%)	N/A
N/A	Painted X Walk1?	No		Road Slope (%)	2.0
	X Walk 1 Direction	To SE		Road X Slope (%)	5.0
	X Walk 1 Width (in)	N/A		Clear Space?	N/A

X Walk 1 Slope (%)	2.0	N/A	Clear Space to XWalk (in)	N/A
	X Walk 1 X Slope (%)	5.0	N/A	Storm Grate/Utility Hazard?	N/A
N/A	Ramp inside XWalk1?	N/A		Storm Grate/Utility Type	
N/A	Any Obstructions?	N/A			N/A
	Obstruction Type		Yes	Surface Condition? (G/P)	Good
			N/A	Curb Slope (%)	14.6

Possible Solutions:

Remove & Replace Entire Ramp.

R304.5.3
