## Access Compliance Report Public Rights-of-Way (Curb Ramps)

Intersection ID: 4839Main Street:TRINITY\_RDCross Street:BEATTIES\_FORD\_RDLocation:NEADA ID: 97AC7049D70DRamp Type:PerpInitial Pass/Fail:FailOverall Compliance:NoSeverity Score:10

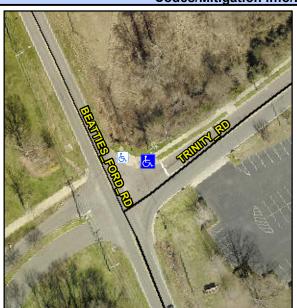
Field Measurements/Component Compliance							
Comp	liance Description	Data	Comp	liance Description	Data		
N/A	Ramp Length (in)	108.0	Yes	Ramp Slope (%)	6.8		
No	Ramp Width (in)	46.0	Yes	Ramp XSlope (%)	2.8		
N/A	Flare Type LT	N/A	N/A	Flare Type RT	N/A		
N/A	Flare Slope LT (%)	N/A	N/A	Flare Slope RT (%)	N/A		
N/A	Flare Traversable LT?	N/A	N/A	Flare Traversable RT?	N/A		
N/A	Landing Length (in)	N/A	N/A	DWS Provided?	N/A		
N/A	Landing Width (in)	N/A	N/A	DWS Contrast?	N/A		
N/A	Landing Slope (%)	N/A	N/A	DWS Length (in)	N/A		
N/A	Landing X Slope (%)	N/A	N/A	DWS Full Width?	N/A		
N/A	Landing Curb? (Y/N)	N/A	N/A	DWS Offset (in)	N/A		
N/A	Shared Landing?	N/A					
N/A	Gutter Ponding?	N/A	N/A	Gutter Slope (%)	N/A		
N/A	Gutter Lip Ht (in)	N/A	N/A	Gutter X Slope (%)	N/A		
N/A	Painted X Walk1?	No	N/A	Painted X Walk2?	N/A		
	X Walk 1 Direction	To S		X Walk 2 Direction	N/A		
N/A	X Walk 1 Width (in)	N/A	N/A	X Walk 2 Width (in)	N/A

X Walk 1 Slope (%)	0.9		X Walk 2 Slope (%)	N/A		
	X Walk 1 X Slope (%)	3.6		X Walk 2 X Slope (%)	N/A		
N/A	Ramp inside XWalk1?	N/A	N/A	Ramp inside XWalk2?	N/A		
	Road Slope (%)	3.6	N/A	Clear Space?	N/A		
	Road X Slope (%)	0.9	N/A	Clear Space to XWalk (in)	N/A		
N/A	Any Obstructions?	N/A	N/A	Storm Grate/Utility Hazard?	N/A		
	Obstruction Type		l	Storm Grate/Utility Type			
		N/A			N/A		
			Yes	Surface Condition? (G/P)	Good		
1

Codes/Mitigation Info/Possible Solution

Total Cost:	\$ 1850.00
