Access Compliance Report Public Rights-of-Way (Curb Ramps)

Intersection ID: 16874 Main Street: IDLEWILD RD **Cross Street: LYNFIELD DR** Location: ADA ID: 97B4FA625B0E Ramp Type: PerpDiag Initial Pass/Fail: Fail **Overall Compliance: No** Severity Score: 13.75

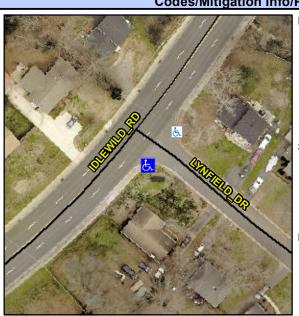
Field Measurements/Component Compliance						
Compliance Description		Data	Comp	liance Description	Data	
N	N/A	Ramp Length (in)	60.0	No	Ramp Slope (%)	9.1
Υ	es/	Ramp Width (in)	48.0	No	Ramp XSlope (%)	3.9
N	I/A	Flare Type LT	N/A	N/A	Flare Type RT	N/A
N	N/A	Flare Slope LT (%)	N/A	N/A	Flare Slope RT (%)	N/A
N	N/A	Flare Traversable LT?	N/A	N/A	Flare Traversable RT?	N/A
N	N/A	Landing Length (in)	N/A	N/A	DWS Provided?	N/A
N	N/A	Landing Width (in)	N/A	N/A	DWS Contrast?	N/A
N	N/A	Landing Slope (%)	N/A	N/A	DWS Length (in)	N/A
N	N/A	Landing X Slope (%)	N/A	N/A	DWS Full Width?	N/A
N	N/A	Landing Curb? (Y/N)	N/A	N/A	DWS Offset (in)	N/A
N	N/A	Shared Landing?	N/A			
N	N/A	Gutter Ponding?	N/A	N/A	Gutter Slope (%)	N/A
N	I/A	Gutter Lip Ht (in)	N/A	N/A	Gutter X Slope (%)	N/A
N	N/A	Painted X Walk1?	No	N/A	Painted X Walk2?	No
		X Walk 1 Direction	To NE		X Walk 2 Direction	To NW
N	N/A	X Walk 1 Width (in)	N/A	N/A	X Walk 2 Width (in)	N/A

X Walk 1 Slope (%)	0.9		X Walk 2 Slope (%)	3.0
		X Walk 1 X Slope (%)	4.5		X Walk 2 X Slope (%)	0.7
N	N/A	Ramp inside XWalk1?	N/A	N/A	Ramp inside XWalk2?	N/A
		Road Slope (%)	4.3	N/A	Clear Space?	N/A
		Road X Slope (%)	6.8	N/A	Clear Space to XWalk (in)	N/A
1	N/A	Any Obstructions?	N/A	N/A	Storm Grate/Utility Hazard?	N/A
		Obstruction Type			Storm Grate/Utility Type	
			N/A			N/A
				Yes	Surface Condition? (G/P)	Good
		1/1

Possible Solutions: Remove & Replace Curb Ramp With Two New Directional Ramps or Equivalent. Surveyor Notes: N/A PROW/ADA: Not Found, R304.2.2, R304.5.3
