# Access Compliance Report

## Public Rights-of-Way

### (Curb Ramps)

| Intersection ID: N/A | Main Street: DELUCA_DR | Cross Street: GALVIN_ST | Location: NE |

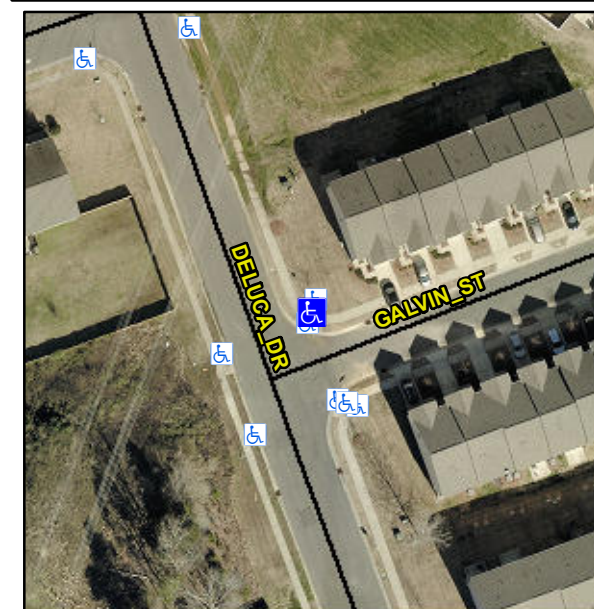
**Not Found, R304.5.3, R304.3.2**

| Compliance | Description | Data | Compliance | Description | Data |
|---|---|---|---|---|---|
| No | Ramp Slope LT (%) | 11.7 | No | Ramp Slope RT (%) | 13.9 |
| Yes | Ramp Width (in) | 48.0 | No | Ramp XSlope (%) | 10.5 |

**Remove & Replace Curb Ramp With Two New Directional Ramps or Equivalent.**
