Access Compliance Report

Public Rights-of-Way

(Curb Ramps)

Intersection ID: 10057	Main Street: ANDRILL_TR	Cross Street: MADISON_AV	Location:	N
ADA ID: 97D1E6930B7B	Ramp Type: Combination1	Initial Pass/Fail: Fail	Overall Compliance: No	Severity Score: 46.25
Codes/Mitigation Info/Possible Solution		Field Measurements/Component Compliance

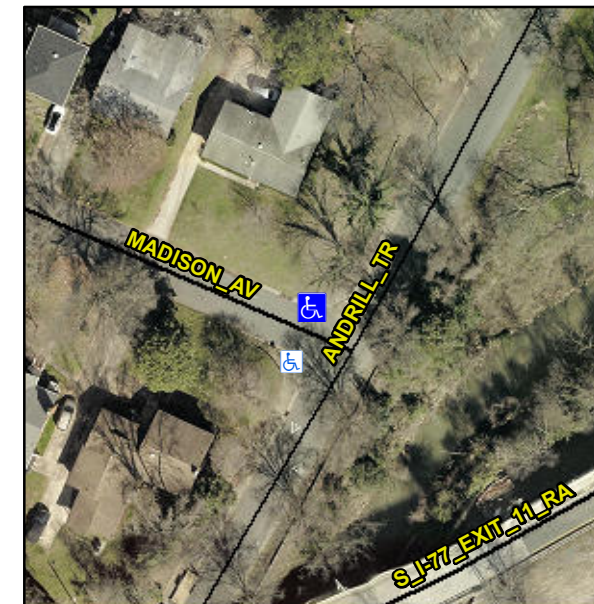
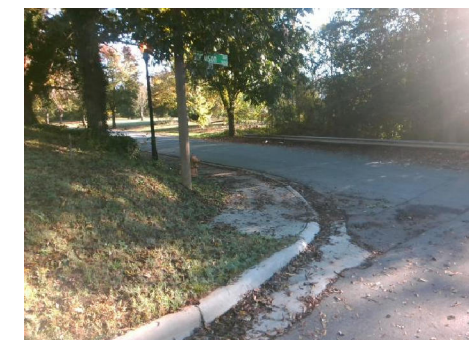
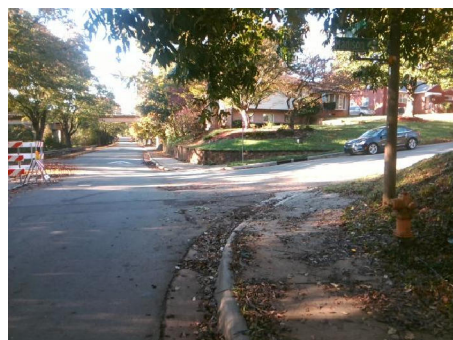
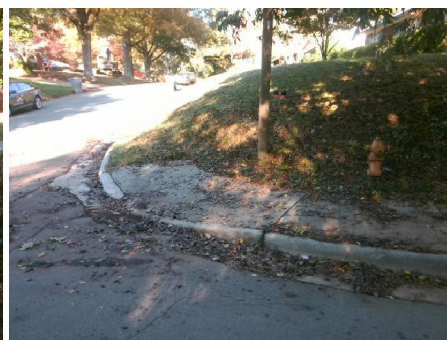
Surveyor Notes:

RP < 5%

PROW/ADA:

Not Found, R304.5.1, R304.5.3, R304.3.2

Compliance	Description	Data	Compliance	Description	Data
N/A	Ramp Length LT (in)	56.5	N/A	Ramp Length RT (in)	48.5
Yes	Ramp Width LT (in)	72.0	Yes	Ramp Width RT (in)	72.0
No	Ramp Slope LT (%)	11.6	Yes	Ramp Slope RT (%)	5.2
No	Ramp XSlope LT (%)	8.6	No	Ramp XSlope RT (%)	8.0
N/A	Ramp Length (in)	72.0	Yes	Ramp Slope (%)	0.1
No	Ramp Width (in)	37.0	No	Ramp XSlope (%)	3.3
N/A	Flare Type LT	N/A	N/A	Flare Type RT	N/A
N/A	Flare Slope LT (%)	N/A	N/A	Flare Slope RT (%)	N/A
N/A	Flare Traversable LT?	N/A	N/A	Flare Traversable RT?	N/A
N/A	Landing Length (in)	N/A	N/A	DWS Provided?	N/A
N/A	Landing Width (in)	N/A	N/A	DWS Contrast?	N/A
N/A	Landing Slope (%)	N/A	N/A	DWS Length (in)	N/A
N/A	Landing X Slope (%)	N/A	N/A	DWS Full Width?	N/A
N/A	Landing Curb? (Y/N)	N/A	N/A	DWS Offset (in)	N/A
N/A	Shared Landing?	N/A			
N/A	Gutter Ponding?	N/A	N/A	Gutter Slope (%)	N/A
N/A	Gutter Lip Ht (in)	N/A	N/A	Gutter X Slope (%)	N/A
N/A	Painted X Walk1?	No	N/A	Painted X Walk2?	N/A

X Walk 1 Direction	To SW		X Walk 2 Direction	N/A
	X Walk 1 Width (in)	N/A		X Walk 2 Width (in)	N/A
	X Walk 1 Slope (%)	12.0		X Walk 2 Slope (%)	N/A
	X Walk 1 X Slope (%)	3.3		X Walk 2 X Slope (%)	N/A
N/A	Ramp inside XWalk1?	N/A	N/A	Ramp inside XWalk2?	N/A
	Road Slope (%)	N/A		Clear Space?	N/A
	Road X Slope (%)	N/A	N/A	Clear Space to XWalk (in)	N/A
			N/A	Any Obstruction?	N/A
				Obstruction Type	N/A
			N/A	Storm Grate/Utility Hazard?	N/A
				Storm Grate/Utility Type	N/A
					N/A
Yes	Surface Condition? (G/P)	Good			
	Curb Slope (%)	18.6

Possible Solutions:

Remove & Replace Entire Ramp.
