# Access Compliance Report

## Public Rights-of-Way

### (Curb Ramps)

| Intersection ID: 10035854 | Main Street: RETANA_DR | Cross Street: N/A | Location: W |

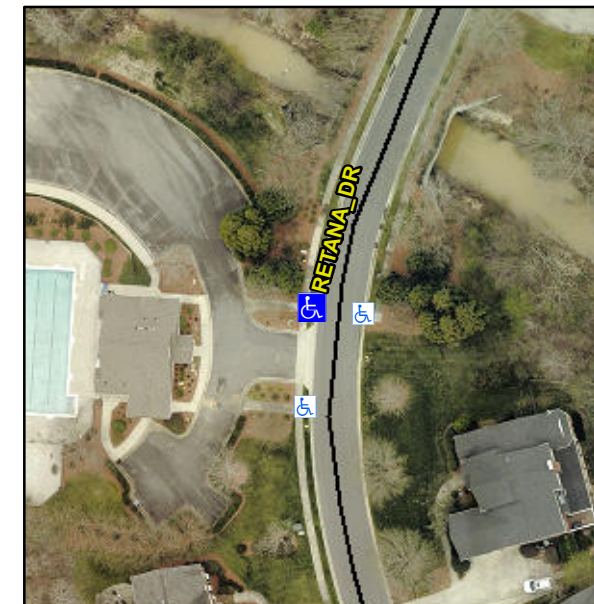
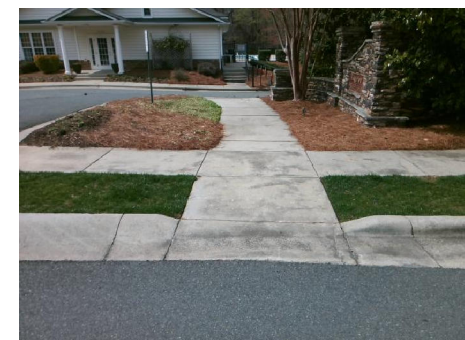
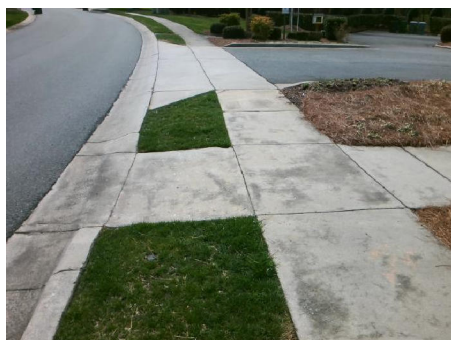
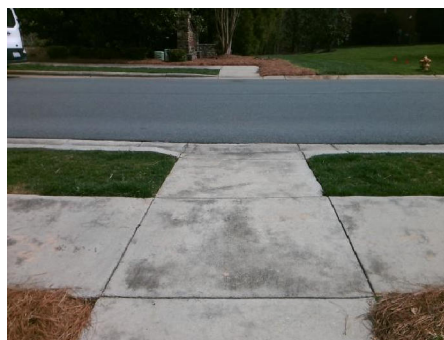
| ADA ID: 97D957573BFE | Ramp Type: BlendTrans1 | Initial Pass/Fail: Pass | Overall Compliance: No |

**R304.5.3, R304.2.1, R305, R304.5.4**

| Compliance | Description | Data | Compliance | Description | Data |
|---|---|---|---|---|---|
| Yes | Ramp Width (in) | 57.0 | No | BlendTrans XSlope (%) | 3.5 |
| No | Landing Length (in) | 47.0 | No | DWS Provided? | No |
| No | Landing X Slope (%) | 3.4 | N/A | DWS Full Width? | No |
| Yes | Gutter Ponding? | No | No | Gutter Slope (%) | 8.1 |
| Yes | Gutter Lip Ht (in) | 0.0 | No | Gutter X Slope (%) | 3.3 |

**Remove & Replace Curb Ramp With Two New Directional Ramps or Equivalent. Remove & Replace Gutter.**

Total Cost: \$ 3950.00
