Access Compliance Report

Public Rights-of-Way

(Curb Ramps)

Intersection ID: 14566	Main Street: PROVIDENCE_RD	Cross Street: S_COLONIAL_AV	Location: W
ADA ID: 97DCABA87675	Ramp Type: BlendTrans2	Initial Pass/Fail: Fail	Overall Compliance: No
		Severity Score: 12.5

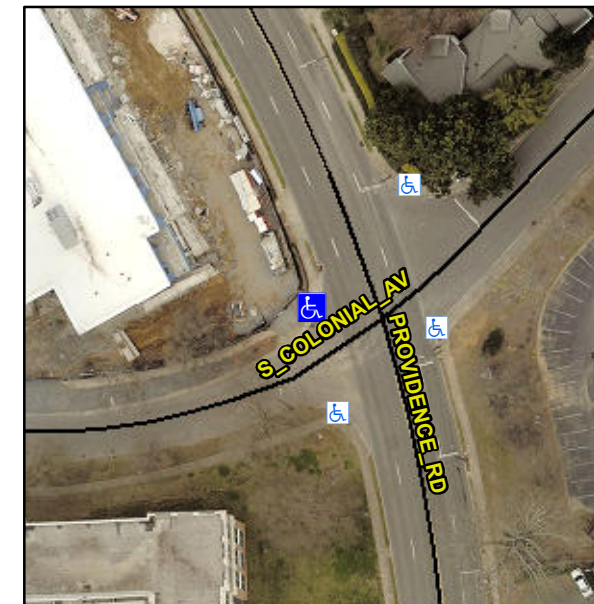
Not Found, R304.5.3

Compliance	Description	Data	Compliance	Description	Data
N/A	Ramp Length (in)	62.0	Yes	BlendTrans Slope (%)	4.4
Yes	Ramp Width (in)	48.0	No	BlendTrans XSlope (%)	6.8
N/A	Flare Type LT	N/A	N/A	Flare Type RT	N/A
N/A	Flare Slope LT (%)	N/A	N/A	Flare Slope RT (%)	N/A
N/A	Flare Traversable LT?	N/A	N/A	Flare Traversable RT?	N/A
N/A	Landing Length (in)	N/A	N/A	DWS Provided?	N/A
N/A	Landing Width (in)	N/A	N/A	DWS Contrast?	N/A
N/A	Landing Slope (%)	N/A	N/A	DWS Length (in)	N/A
N/A	Landing X Slope (%)	N/A	N/A	DWS Full Width?	N/A
N/A	Landing Curb? (Y/N)	N/A	N/A	DWS Offset (in)	N/A
N/A	Shared Landing?	N/A			
N/A	Gutter Ponding?	N/A	N/A	Gutter Slope (%)	N/A
N/A	Gutter Lip Ht (in)	N/A	N/A	Gutter X Slope (%)	N/A
N/A	Painted X Walk1?	No	N/A	Painted X Walk2?	No
	X Walk 1 Direction	To S		X Walk 2 Direction	To NE
	X Walk 1 Width (in)	N/A		X Walk 2 Width (in)	N/A
	X Walk 1 Slope (%)	1.3		X Walk 2 Slope (%)	5.2
	X Walk 1 X Slope (%)	5.2		X Walk 2 X Slope (%)	0.5

N/A	Ramp inside XWalk1?	N/A	N/A	Ramp inside XWalk2?	N/A
	Road Slope (%)	3.9		Clear Space?	N/A
	Road X Slope (%)	5.6	N/A	Clear Space to XWalk (in)	N/A
N/A	Any Obstructions?	N/A	N/A	Storm Grate/Utility Hazard?	N/A
	Obstruction Type			Storm Grate/Utility Type	
		N/A			N/A
			Yes	Surface Condition? (G/P)	Good
			No	Curb Slope (%)	15.6

Remove & Replace Curb Ramp With Two New Directional Ramps or Equivalent.
