# Access Compliance Report

## Public Rights-of-Way

Intersection ID: N/A	Main Street: INVERNESS_BAY_RD	Cross Street: DALLAS_BAY_RD	Location: SW
ADA ID: 97DF20834C66	Ramp Type: PerpDiag	Initial Pass/Fail: Fail	Overall Compliance: No
		Severity Score: 12.5

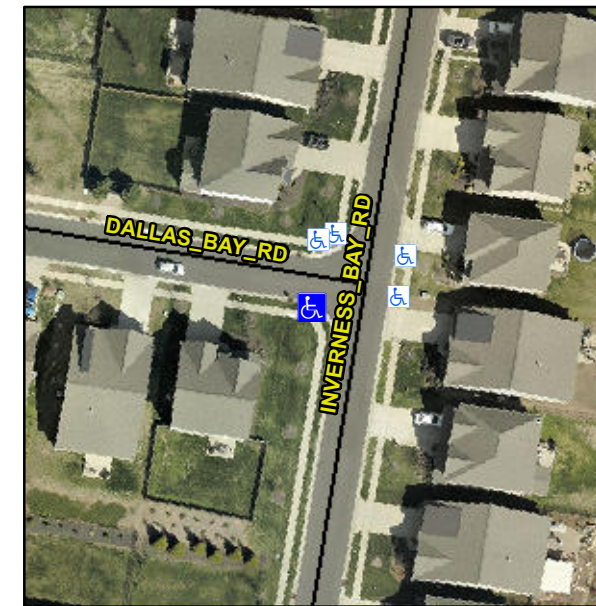
Compliance	Description	Data	Compliance	Description	Data
N/A	Ramp Length (in)	47.5	No	Ramp Slope (%)	10.9
Yes	Ramp Width (in)	48.0	Yes	Ramp XSlope (%)	1.8
N/A	Flare Type LT	N/A	N/A	Flare Type RT	N/A
N/A	Flare Slope LT (%)	N/A	N/A	Flare Slope RT (%)	N/A
N/A	Flare Traversable LT?	N/A	N/A	Flare Traversable RT?	N/A
N/A	Landing Length (in)	N/A	N/A	DWS Provided?	N/A
N/A	Landing Width (in)	N/A	N/A	DWS Contrast?	N/A
N/A	Landing Slope (%)	N/A	N/A	DWS Length (in)	N/A
N/A	Landing X Slope (%)	N/A	N/A	DWS Full Width?	N/A
N/A	Landing Curb? (Y/N)	N/A	N/A	DWS Offset (in)	N/A
N/A	Shared Landing?	N/A			
N/A	Gutter Ponding?	N/A	N/A	Gutter Slope (%)	N/A
N/A	Gutter Lip Ht (in)	1.0	N/A	Gutter X Slope (%)	N/A
N/A	Painted X Walk1?	No	N/A	Painted X Walk2?	No
	X Walk 1 Direction	To SE		X Walk 2 Direction	To NE
N/A	X Walk 1 Width (in)	N/A	N/A	X Walk 2 Width (in)	N/A
	X Walk 1 Slope (%)	2.6		X Walk 2 Slope (%)	2.5
	X Walk 1 X Slope (%)	3.1		X Walk 2 X Slope (%)	0.5

N/A	Ramp inside XWalk1?	N/A	N/A	Ramp inside XWalk2?	N/A
	Road Slope (%)	1.9	N/A	Clear Space?	N/A
	Road X Slope (%)	3.1	N/A	Clear Space to XWalk (in)	N/A
N/A	Any Obstructions?	N/A	N/A	Storm Grate/Utility Hazard?	N/A
	Obstruction Type			Storm Grate/Utility Type	
		N/A			N/A
			Yes	Surface Condition? (G/P)	Good

**Remove & Replace Curb Ramp With Two New Directional Ramps or Equivalent.**

**R304.2.2**

Total Cost: \$ 3200.00
