# Access Compliance Report

## Public Rights-of-Way

### (Curb Ramps)

| Intersection ID: 53930 | Main Street: STARNES RANDALL RD | Cross Street: BRITTONDALE LN | Location: SW |

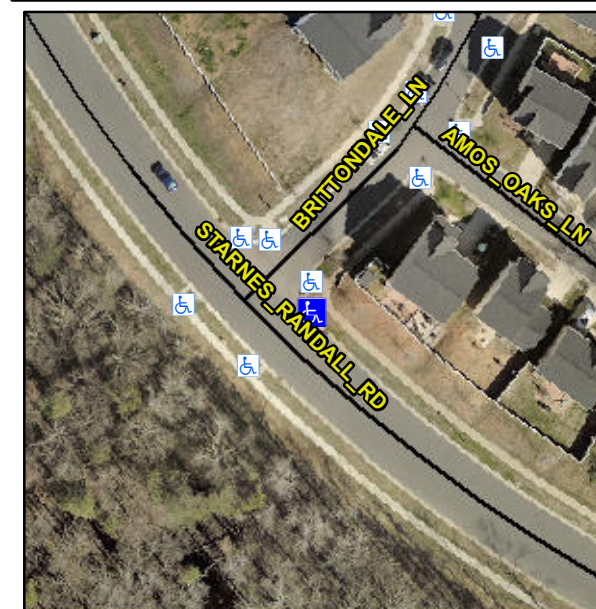
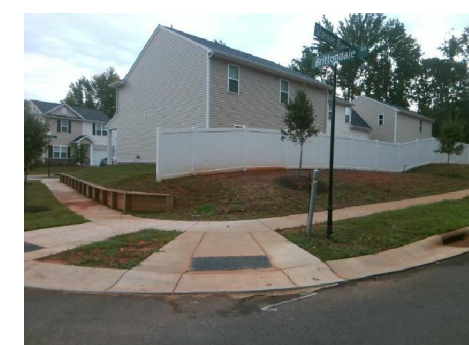
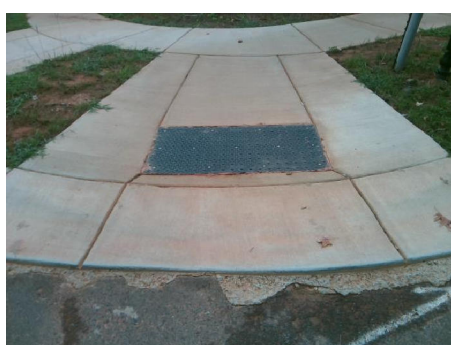
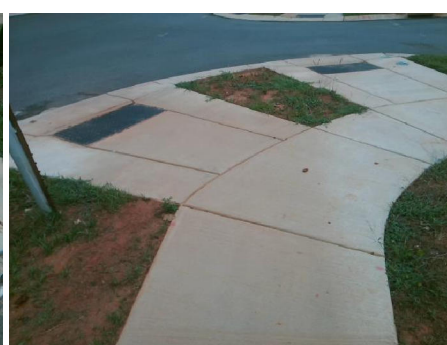
| ADA ID: 97E74AD61D02 | Ramp Type: Perp | Initial Pass/Fail: Fail | Overall Compliance: No |
| Severity Score: 18.75 | | | |

**Not Found, R304.5.1**

| Compliance | Description | Data | Compliance | Description | Data |
|---|---|---|---|---|---|
| No | Ramp Width (in) | 34.5 | Yes | Ramp XSlope (%) | 2.2 |

**Remove & Replace Entire Ramp.**

Total Cost: \$ 1850.00
