Access Compliance Report

Public Rights-of-Way

(Curb Ramps)

Intersection ID: 2912	Main Street: CRYSTAL_LEAF_PL	Cross Street: FOREST_PATH_DR	Location:	N
ADA ID: 97F779223EE3	Ramp Type: Perp	Initial Pass/Fail: Fail	Overall Compliance: No	Severity Score: 13.75
Codes/Mitigation Info/Possible Solution		Field Measurements/Component Compliance

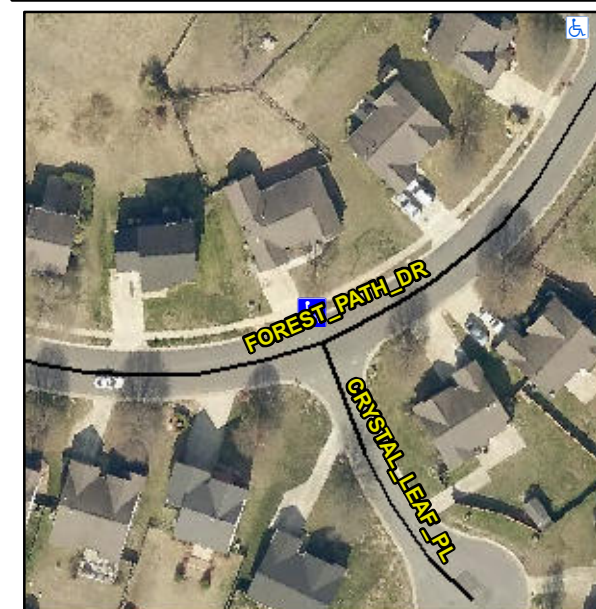
Compliance	Description	Data	Compliance	Description	Data
N/A	Ramp Length (in)	48.0	No	Ramp Slope (%)	11.5
Yes	Ramp Width (in)	53.0	Yes	Ramp XSlope (%)	2.2
N/A	Flare Type LT	N/A	N/A	Flare Type RT	N/A
N/A	Flare Slope LT (%)	N/A	N/A	Flare Slope RT (%)	N/A
N/A	Flare Traversable LT?	N/A	N/A	Flare Traversable RT?	N/A
N/A	Landing Length (in)	N/A	N/A	DWS Provided?	N/A
N/A	Landing Width (in)	N/A	N/A	DWS Contrast?	N/A
N/A	Landing Slope (%)	N/A	N/A	DWS Length (in)	N/A
N/A	Landing X Slope (%)	N/A	N/A	DWS Full Width?	N/A
N/A	Landing Curb? (Y/N)	N/A	N/A	DWS Offset (in)	N/A
N/A	Shared Landing?	N/A			
N/A	Gutter Ponding?	N/A	N/A	Gutter Slope (%)	N/A
N/A	Gutter Lip Ht (in)	N/A	N/A	Gutter X Slope (%)	N/A
N/A	Painted X Walk1?	No	N/A	Painted X Walk2?	N/A
	X Walk 1 Direction	To S		X Walk 2 Direction	N/A
N/A	X Walk 1 Width (in)	N/A	N/A	X Walk 2 Width (in)	N/A
	X Walk 1 Slope (%)	N/A		X Walk 2 Slope (%)	N/A
	X Walk 1 X Slope (%)	N/A		X Walk 2 X Slope (%)	N/A

N/A	Ramp inside XWalk1?	N/A	N/A	Ramp inside XWalk2?	N/A
	Road Slope (%)	1.1	N/A	Clear Space?	N/A
	Road X Slope (%)	11.9	N/A	Clear Space to XWalk (in)	N/A
N/A	Any Obstructions?	N/A	N/A	Storm Grate/Utility Hazard?	N/A
	Obstruction Type			Storm Grate/Utility Type	
		N/A			N/A
			Yes	Surface Condition? (G/P)	Good

Possible Solutions:

Remove & Replace Entire Ramp.
