# Access Compliance Report

## Public Rights-of-Way

### (Curb Ramps)

Intersection ID: 53147	Main Street: ACHIEVEMENT_LN	Cross Street: NEW_RENAISSANCE_WY	Location: NE
ADA ID: 980C40A2600D	Ramp Type: Perp	Initial Pass/Fail: Fail	Overall Compliance: No
Severity Score: 12.5			
Codes/Mitigation Info/Possible Solution		Field Measurements/Component Compliance

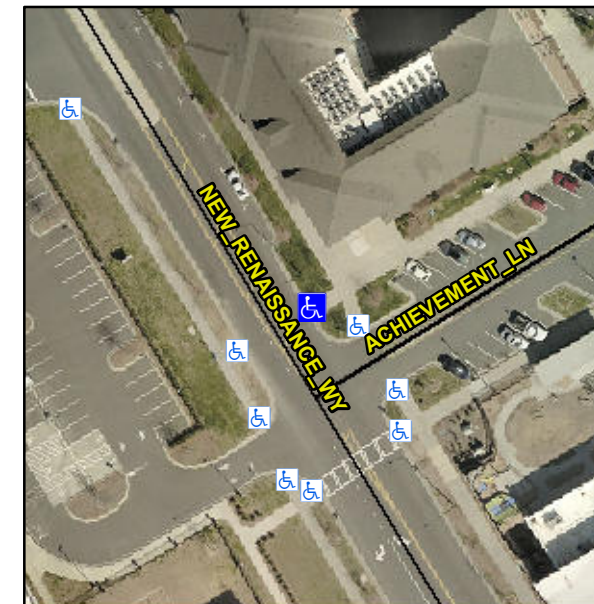
Compliance	Description	Data	Compliance	Description	Data
N/A	Ramp Length (in)	96.0	No	Ramp Slope (%)	9.6
Yes	Ramp Width (in)	95.0	Yes	Ramp XSlope (%)	1.4
N/A	Flare Type LT	N/A	N/A	Flare Type RT	N/A
N/A	Flare Slope LT (%)	N/A	N/A	Flare Slope RT (%)	N/A
N/A	Flare Traversable LT?	N/A	N/A	Flare Traversable RT?	N/A
N/A	Landing Length (in)	N/A	N/A	DWS Provided?	N/A
N/A	Landing Width (in)	N/A	N/A	DWS Contrast?	N/A
N/A	Landing Slope (%)	N/A	N/A	DWS Length (in)	N/A
N/A	Landing X Slope (%)	N/A	N/A	DWS Full Width?	N/A
N/A	Landing Curb? (Y/N)	N/A	N/A	DWS Offset (in)	N/A
N/A	Shared Landing?	N/A			
N/A	Gutter Ponding?	N/A	N/A	Gutter Slope (%)	N/A
N/A	Gutter Lip Ht (in)	N/A	N/A	Gutter X Slope (%)	N/A
N/A	Painted X Walk1?	No	N/A	Painted X Walk2?	N/A
	X Walk 1 Direction	To SW		X Walk 2 Direction	N/A
N/A	X Walk 1 Width (in)	N/A	N/A	X Walk 2 Width (in)	N/A
	X Walk 1 Slope (%)	2.2		X Walk 2 Slope (%)	N/A
	X Walk 1 X Slope (%)	1.6		X Walk 2 X Slope (%)	N/A

N/A	Ramp inside XWalk1?	N/A	N/A	Ramp inside XWalk2?	N/A
	Road Slope (%)	N/A	N/A	Clear Space?	N/A
	Road X Slope (%)	N/A	N/A	Clear Space to XWalk (in)	N/A
N/A	Any Obstructions?	N/A	N/A	Storm Grate/Utility Hazard?	N/A
	Obstruction Type			Storm Grate/Utility Type	
		N/A			N/A
		Yes		Surface Condition? (G/P)	Good

Possible Solutions:

**Remove & Replace Entire Ramp.**

**R304.2.2**

**\$ 1850.00**
