# Access Compliance Report

## Public Rights-of-Way (Curb Ramps)

Intersection ID: 13086	Main Street: CENTRAL_AV	Cross Street: CLEMENT_AV	Location: SE
ADA ID: 980CDC03C77B	Ramp Type: Directional1	Initial Pass/Fail: Fail	Overall Compliance: No
		Severity Score: 13.75

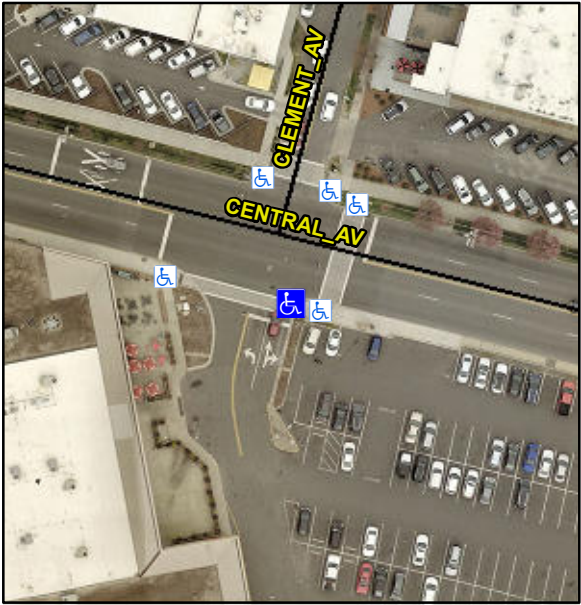
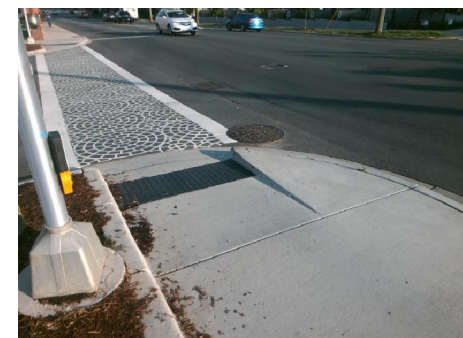
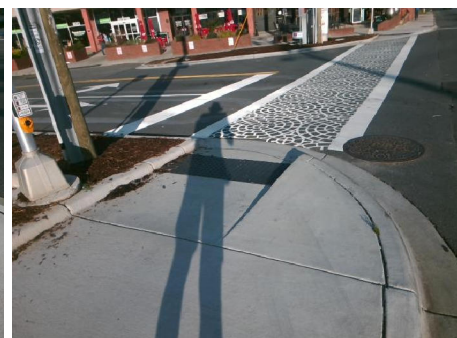
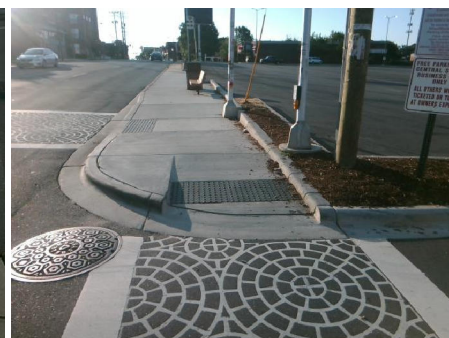
Possible Solutions:		<b>Compliance</b>	<b>Description</b>	<b>Data</b>	
	<b>Remove &amp; Replace Entire Ramp.</b>		N/A	Ramp Length (in)	67.0	
			Yes	Ramp Width (in)	57.0	
			No	Ramp Slope (%)	9.1	
			Yes	Ramp XSlope (%)	2.6	
			N/A	Flare Type LT	N/A	
			N/A	Flare Slope LT (%)	N/A	
			N/A	Flare Traversable LT?	N/A	
			N/A	Landing Length (in)	0.0	
			N/A	Landing Width (in)	0.0	
<p>Surveyor Notes:</p> <p><b>ACCESS AISLE RAMP</b></p> <p>PROW/ADA:</p> <p><b>R304.2.2</b></p>			N/A	Flare Slope RT (%)	0.0	
			N/A	Flare Traversable RT?	N/A	
			N/A	DWS Provided?	N/A	
			N/A	DWS Contrast?	N/A	
			N/A	DWS Length (in)	N/A	
			N/A	DWS Full Width?	N/A	
			N/A	DWS Offset LT (in)	N/A	
			N/A	DWS Offset RT (in)	N/A	
			N/A	Gutter Slope (%)	N/A	
			N/A	Gutter X Slope (%)	N/A	
			N/A	Gutter Lip Ht (in)	0.0	
			N/A	Painted X Walk1?	Yes	
				Road Slope (%)	5.9

Road X Slope (%)	3.0	
				Clear Space?	N/A	
			N/A	Clear Space to XWalk (in)	N/A	
			N/A	Storm Grate/Utility Hazard?	N/A	
			N/A	Storm Grate/Utility Type		
			N/A	Any Obstructions?	N/A	
				Obstruction Type		
			Yes	Surface Condition? (G/P)	Good	
			N/A	Curb Slope (%)	8.8	
Total Cost:		\$ 1600.00
