## Access Compliance Report Public Rights-of-Way (Curb Ramps)

Intersection ID: 51704Main Street:IKEA\_BVCross Street:BROOKSIDE\_LNLocation:NEADA ID: 9812A9446D38Ramp Type:PerpInitial Pass/Fail:FailOverall Compliance:NoSeverity Score:13.75

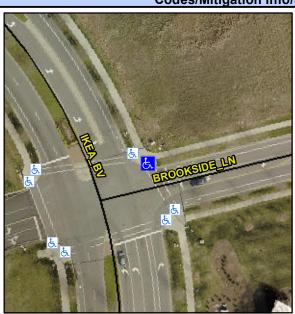
Fleid Measurements/Component Compnance						
Compliance Description Data			Compliance Description		Data	
N/A	Ramp Length (in)	94.0	No	Ramp Slope (%)	8.5	
Yes	Ramp Width (in)	48.0	Yes	Ramp XSlope (%)	4.5	
N/A	Flare Type LT	N/A	N/A	Flare Type RT	N/A	
N/A	Flare Slope LT (%)	N/A	N/A	Flare Slope RT (%)	N/A	
N/A	Flare Traversable LT?	N/A	N/A	Flare Traversable RT?	N/A	
N/A	Landing Length (in)	N/A	N/A	DWS Provided?	N/A	
N/A	Landing Width (in)	N/A	N/A	DWS Contrast?	N/A	
N/A	Landing Slope (%)	N/A	N/A	DWS Length (in)	N/A	
N/A	Landing X Slope (%)	N/A	N/A	DWS Full Width?	N/A	
N/A	Landing Curb? (Y/N)	N/A	N/A	DWS Offset (in)	N/A	
N/A	Shared Landing?	N/A				
N/A	Gutter Ponding?	N/A	N/A	Gutter Slope (%)	N/A	
N/A	Gutter Lip Ht (in)	0.5	N/A	Gutter X Slope (%)	N/A	
N/A	Painted X Walk1?	Yes	N/A	Painted X Walk2?	N/A	
	X Walk 1 Direction	To SE		X Walk 2 Direction	N/A	
N/A	X Walk 1 Width (in)	95.0	N/A	X Walk 2 Width (in)	N/A	
	X Walk 1 Slope (%)	1.0		X Walk 2 Slope (%)	N/A

X Walk 1 X Slope (%)	4.5		X Walk 2 X Slope (%)	N/A	
N/A	Ramp inside XWalk1?	Yes	N/A	Ramp inside XWalk2?	N/A	
	Road Slope (%)	N/A	N/A	Clear Space?	N/A	
	Road X Slope (%)	N/A	N/A	Clear Space to XWalk (in)	N/A	
N/A	Any Obstructions?	N/A	N/A	Storm Grate/Utility Hazard?	N/A	
	Obstruction Type		l	Storm Grate/Utility Type		
		N/A			N/A	
			Yes	Surface Condition? (G/P)	Good

Possible Solutions:	Com
Remove & Replace Entire Ramp.	N/A
	Yes
	N/A
	N/A
	N/A
	N/A
Surveyor Notes:	N/A
N/A	N/A
	N/A
	N/A
	N/A
PROW/ADA:	N/A
Not Found, R304.2.2	N/A
·	N/A
	N/A
	N/A
