# Access Compliance Report

## Public Rights-of-Way

### (Curb Ramps)

| Intersection ID: 10038956 | Main Street: STONEMEDE_LN | Cross Street: N/A | Location: W |

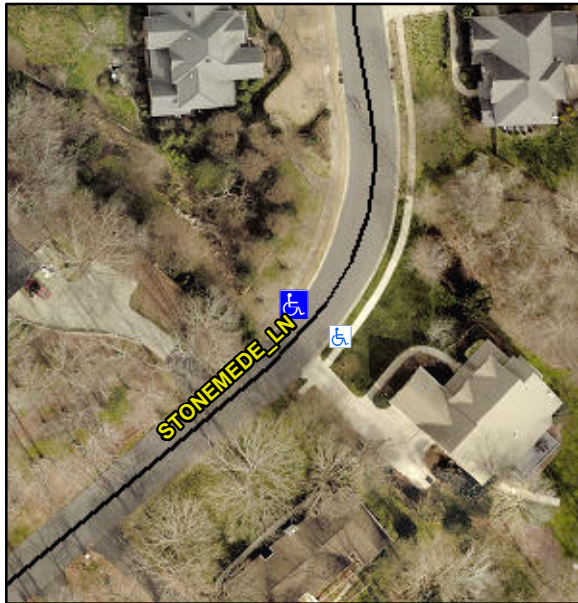
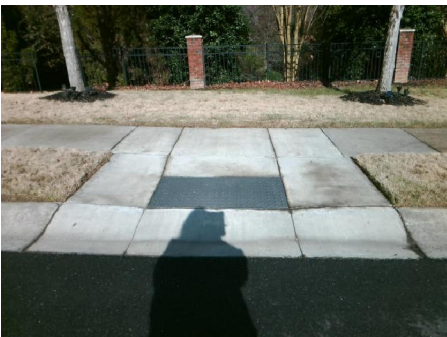
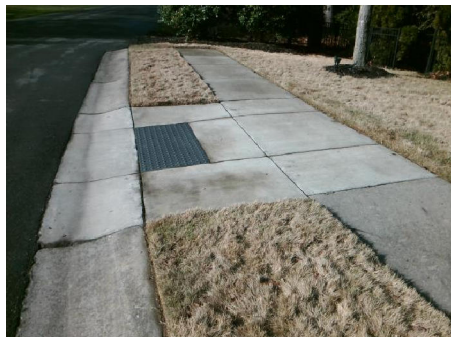
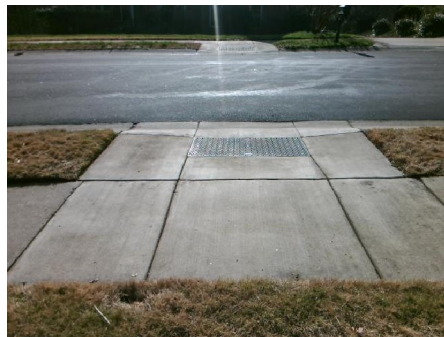
| ADA ID: 9828B0D3D4A1 | Ramp Type: BlendTrans1 | Initial Pass/Fail: Pass | Overall Compliance: No |

**Not Found, R304.5.4**

| Compliance | Description | Data | Compliance | Description | Data |
|---|---|---|---|---|---|
| Yes | Gutter Ponding? | No | No | Gutter Slope (%) | 9.7 |
| | | | No | Curb Slope (%) | 12.2 |

**Remove & Replace Curb Slope and Extend Ramp. Remove & Replace Gutter.**

Total Cost: \$ 2750.00
