Access Compliance Report Public Rights-of-Way (Curb Ramps)

| Intersection ID: 50583 Main | Main Street: GRAND_FIR_RD | | Cross Street: LONGSTRAW_RD | | | | Location: | SE |
| ADA ID: 9837FEA990C9 Ramp | Ramp Type: Perp | | Initial Pass/Fail: Fail Overall Compliance: | | | nce: N | o Severity Score: | 10 |

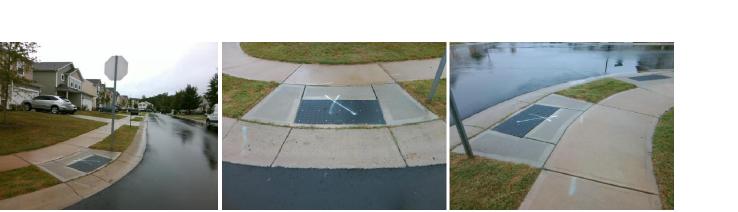
| Intersection ID: 50583 Main | Main Street: GRAND_FIR_RD | | Cross Street: LONGSTRAW_RD | | | | Location: | SE |
|---|---|---|---|---|---|---|---|---|
| ALL TRACE | Remove & Replace Entire Ramp | . <u>N</u> | /A | Ramp Length (in) | 48.0 | Yes | Ramp Slope (%) | 8.0 |
| have been to be the second | 2 · · · · · · · · · · · · · · · · · · · | N | o | Ramp Width (in) | 46.5 | No | Ramp XSlope (%) | 3.1 |
| | Not Found, R304.5.1, R304.5.3 | N/ | /A | Gutter Lip Ht (in) | N/A | N/A | Gutter X Slope (%) | N/A |

| Intersection ID: 50583 Main | Main Street: GRAND_FIR_RD | | Cross Street: LONGSTRAW_RD | | | | Location: | SE |
|---|---|---|---|---|---|---|---|---|
| | Total Cost: \$ | 1850.00 | | Obstruction Type | | | Storm Grate/Utility Type | |
