# Access Compliance Report

## Public Rights-of-Way

### (Curb Ramps)

| Intersection ID: 11428 | Main Street: THE_PLAZA | Cross Street: DUNCAN_AV | Location: NE |

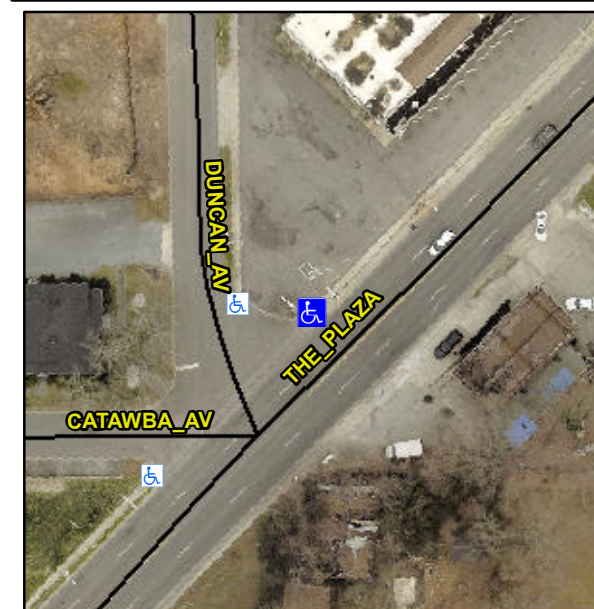
**R304.2.2, R304.5.3**

| Compliance | Description | Data | Compliance | Description | Data |
|---|---|---|---|---|---|
| N/A | Ramp Length (in) | 51.5 | No | Ramp Slope (%) | 11.5 |
| Yes | Ramp Width (in) | 60.0 | No | Ramp XSlope (%) | 3.8 |
| N/A | Gutter Ponding? | Yes | N/A | Gutter Slope (%) | N/A |

**Remove & Replace Entire Ramp.**

Total Cost: \$ 1850.00
