# Access Compliance Report

## Public Rights-of-Way

### (Curb Ramps)

Intersection ID: 4810	Main Street: BEN_CRAIG_DR	Cross Street: MALLARD_CREEK_RD	Location:	N
ADA ID: 9842802DD9B9	Ramp Type: Perp	Initial Pass/Fail: Fail	Overall Compliance: No	Severity Score: 22.5
Codes/Mitigation Info/Possible Solution		Field Measurements/Component Compliance

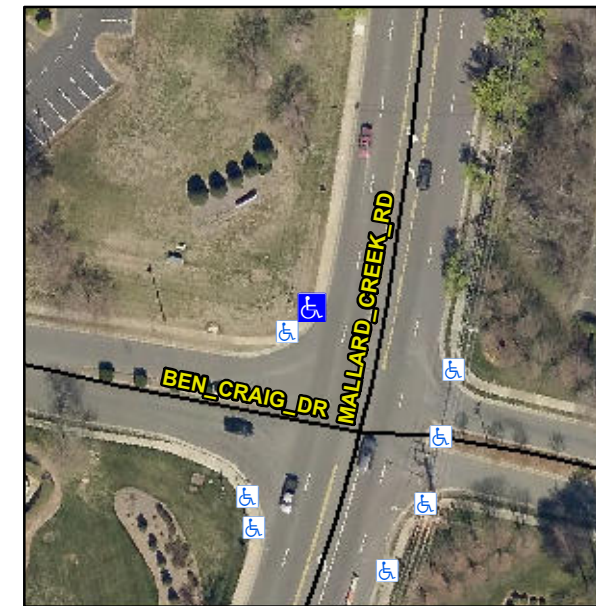
**Not Found, R304.5.1, R304.2.2**

Compliance	Description	Data	Compliance	Description	Data
N/A	Ramp Length (in)	61.0	No	Ramp Slope (%)	9.6
No	Ramp Width (in)	41.0	Yes	Ramp XSlope (%)	2.3
N/A	Flare Type LT	N/A	N/A	Flare Type RT	N/A
N/A	Flare Slope LT (%)	N/A	N/A	Flare Slope RT (%)	N/A
N/A	Flare Traversable LT?	N/A	N/A	Flare Traversable RT?	N/A
N/A	Landing Length (in)	N/A	N/A	DWS Provided?	N/A
N/A	Landing Width (in)	N/A	N/A	DWS Contrast?	N/A
N/A	Landing Slope (%)	N/A	N/A	DWS Length (in)	N/A
N/A	Landing X Slope (%)	N/A	N/A	DWS Full Width?	N/A
N/A	Landing Curb? (Y/N)	N/A	N/A	DWS Offset (in)	N/A
N/A	Shared Landing?	N/A			
N/A	Gutter Ponding?	N/A	N/A	Gutter Slope (%)	N/A
N/A	Gutter Lip Ht (in)	N/A	N/A	Gutter X Slope (%)	N/A
N/A	Painted X Walk1?	No	N/A	Painted X Walk2?	N/A
	X Walk 1 Direction	To SE		X Walk 2 Direction	N/A
N/A	X Walk 1 Width (in)	N/A	N/A	X Walk 2 Width (in)	N/A
	X Walk 1 Slope (%)	4.5		X Walk 2 Slope (%)	N/A
	X Walk 1 X Slope (%)	4.4		X Walk 2 X Slope (%)	N/A

**Remove & Replace Entire Ramp.**

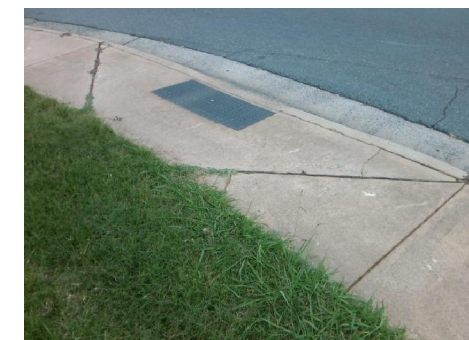
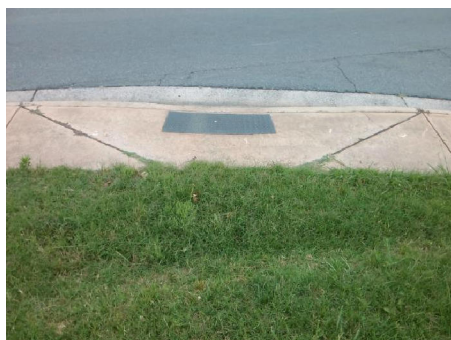
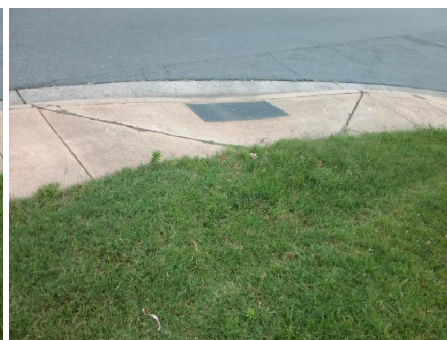
N/A	Ramp inside XWalk1?	N/A	N/A	Ramp inside XWalk2?	N/A
	Road Slope (%)	N/A	N/A	Clear Space?	N/A
	Road X Slope (%)	N/A	N/A	Clear Space to XWalk (in)	N/A
N/A	Any Obstructions?	N/A	N/A	Storm Grate/Utility Hazard?	N/A
	Obstruction Type			Storm Grate/Utility Type	
		N/A			N/A
			Yes	Surface Condition? (G/P)	Good
