# Access Compliance Report

## Public Rights-of-Way

### (Curb Ramps)

Intersection ID: 49183	Main Street: ST_JOHN_LN	Cross Street: ST_STEPHEN_LN	Location: NW
ADA ID: 984E4290CA8E	Ramp Type: ParaDiag	Initial Pass/Fail: Fail	Overall Compliance: No
Codes/Mitigation Info/Possible Solution			Severity Score: 10
			Field Measurements/Component Compliance

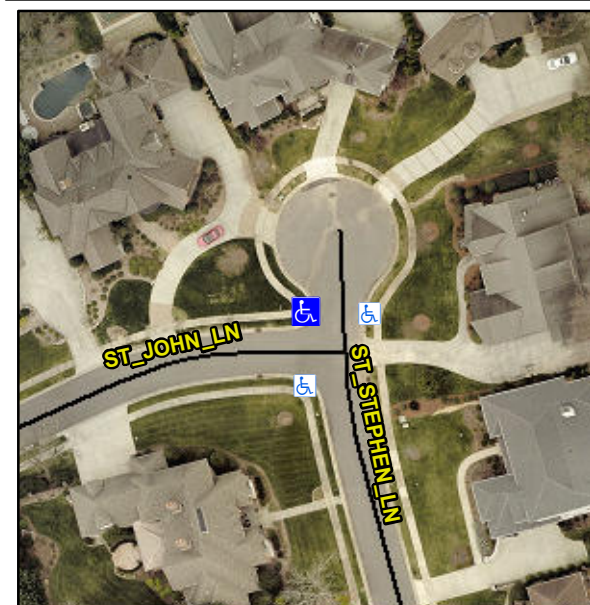
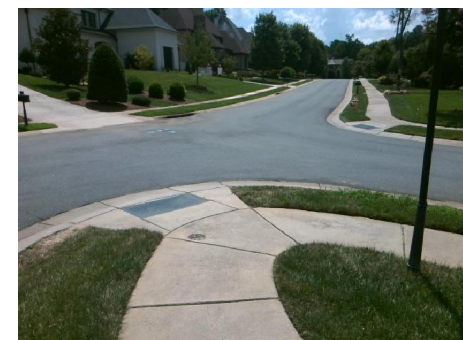
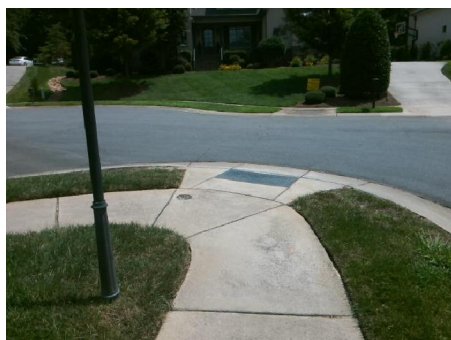
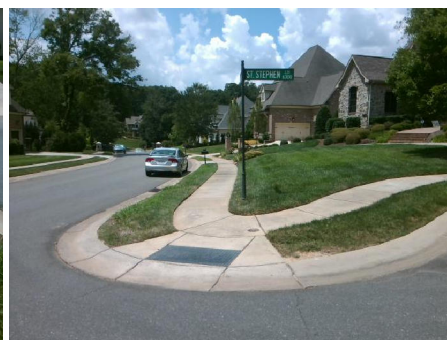
**LT RP < 5%**

**R304.5.1, R304.5.3**

Compliance	Description	Data	Compliance	Description	Data
N/A	Ramp Length LT (in)	46.0	N/A	Ramp Length RT (in)	35.0
No	Ramp Width LT (in)	46.5	No	Ramp Width RT (in)	46.5
Yes	Ramp Slope LT (%)	3.7	Yes	Ramp Slope RT (%)	8.2
No	Ramp XSlope LT (%)	4.3	No	Ramp XSlope RT (%)	2.9
N/A	Landing Length (in)	N/A	N/A	DWS Provided?	N/A
N/A	Landing Width (in)	N/A	N/A	DWS Contrast?	N/A
N/A	Landing Slope (%)	N/A	N/A	DWS Length (in)	N/A
N/A	Landing X Slope (%)	N/A	N/A	DWS Full Width?	N/A
N/A	Landing Curb? (Y/N)	N/A	N/A	DWS Offset (in)	N/A
N/A	Shared Landing?	N/A			
N/A	Gutter Ponding?	N/A	N/A	Gutter Slope (%)	N/A
N/A	Gutter Lip Ht (in)	N/A	N/A	Gutter X Slope (%)	N/A
N/A	Painted X Walk1?	No	N/A	Painted X Walk2?	No
	X Walk 1 Direction	To S		X Walk 2 Direction	To E
N/A	X Walk 1 Width (in)	N/A	N/A	X Walk 2 Width (in)	N/A
	X Walk 1 Slope (%)	3.2		X Walk 2 Slope (%)	1.9
	X Walk 1 X Slope (%)	3.4		X Walk 2 X Slope (%)	2.8
N/A	Ramp inside XWalk1?	N/A	N/A	Ramp inside XWalk2?	N/A

Road Slope (%)	4.2	N/A	Clear Space?	N/A
	Road X Slope (%)	3.7	N/A	Clear Space to XWalk (in)	N/A
N/A	Any Obstructions?	N/A	N/A	Storm Grate/Utility Hazard?	N/A
	Obstruction Type			Storm Grate/Utility Type	
		N/A			N/A
			Yes	Surface Condition? (G/P)	Good
			N/A	Curb Slope (%)	4.7

**Remove & Replace Curb Ramp With Two New Directional Ramps or Equivalent.**
