# Access Compliance Report

## Public Rights-of-Way

### (Curb Ramps)

Intersection ID: 14337	Main Street: BERKELEY_AV	Cross Street: E_MOREHEAD_ST	Location: SW
ADA ID: 985D75CE7FB9	Ramp Type: Directional1	Initial Pass/Fail: Fail	Overall Compliance: No
		Severity Score: 12.5

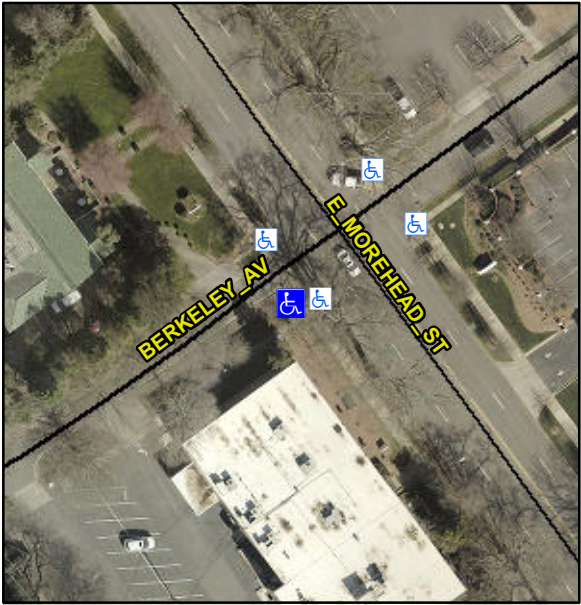
Possible Solutions:		<b>Compliance</b>	<b>Description</b>	<b>Data</b>	
	<b>Remove &amp; Replace Entire Ramp.</b>		<b>N/A</b>	Ramp Length (in)	<b>30.0</b>	<b>N/A</b>
			<b>Yes</b>	Ramp Width (in)	<b>54.0</b>	<b>N/A</b>
			<b>Yes</b>	Ramp Slope (%)	<b>0.8</b>	<b>N/A</b>
			<b>No</b>	Ramp XSlope (%)	<b>5.2</b>	<b>N/A</b>
			<b>N/A</b>	Flare Type LT	<b>N/A</b>	<b>N/A</b>
			<b>N/A</b>	Flare Slope LT (%)	<b>N/A</b>	<b>N/A</b>
			<b>N/A</b>	Flare Traversable LT?	<b>N/A</b>	<b>N/A</b>
			<b>N/A</b>	Landing Length (in)	<b>0.0</b>	<b>N/A</b>
			<b>N/A</b>	Landing Width (in)	<b>0.0</b>	<b>N/A</b>
			<b>N/A</b>	Landing Slope (%)	<b>0.0</b>	<b>N/A</b>
			<b>N/A</b>	Landing X Slope (%)	<b>0.0</b>	<b>N/A</b>
			<b>N/A</b>	Landing Curb? (Y/N)	<b>N/A</b>	<b>N/A</b>
			<b>N/A</b>	Shared Landing?	<b>N/A</b>	<b>N/A</b>
			<b>N/A</b>	Gutter Ponding?	<b>0.0</b>	<b>N/A</b>

<b>N/A</b>	Gutter Lip Ht (in)	<b>0.0</b>	<b>N/A</b>
			<b>N/A</b>	Painted X Walk1?	<b>No</b>	<b>N/A</b>
				X Walk 1 Direction	<b>To NW</b>	<b>N/A</b>
				X Walk 1 Width (in)	<b>N/A</b>	<b>N/A</b>
				X Walk 1 Slope (%)	<b>4.9</b>	<b>N/A</b>
				X Walk 1 X Slope (%)	<b>5.0</b>	<b>N/A</b>
<p>Surveyor Notes:</p> <p><b>N/A</b></p>			<b>N/A</b>	Ramp inside XWalk1?	<b>N/A</b>	<b>N/A</b>
			<b>N/A</b>	Any Obstructions?	<b>N/A</b>	<b>N/A</b>
<p>PROW/ADA:</p> <p><b>R304.5.3</b></p>				Obstruction Type		<b>Yes</b>
						<b>N/A</b>
Total Cost:			<b>\$</b>	<b>1600.00</b>		<b>Good</b>
						<b>10.3</b>
