# Access Compliance Report

## Public Rights-of-Way

### (Curb Ramps)

Intersection ID: 17009	Main Street: N_WENDOVER_RD	Cross Street: RANDOLPH_RD	Location: W
ADA ID: 986982A6AF61	Ramp Type: Perp	Initial Pass/Fail: Fail	Overall Compliance: No
Severity Score: 33.75			
Codes/Mitigation Info/Possible Solution		Field Measurements/Component Compliance

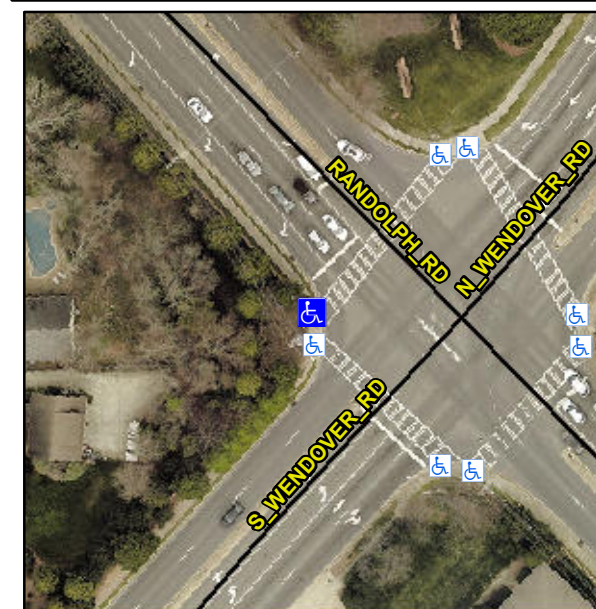
**R304.5.1, R304.5.3**

Compliance	Description	Data	Compliance	Description	Data
N/A	Ramp Length (in)	82.5	Yes	Ramp Slope (%)	7.8
No	Ramp Width (in)	46.0	No	Ramp XSlope (%)	7.3
N/A	Flare Type LT	N/A	N/A	Flare Type RT	N/A
N/A	Flare Slope LT (%)	N/A	N/A	Flare Slope RT (%)	N/A
N/A	Flare Traversable LT?	N/A	N/A	Flare Traversable RT?	N/A
N/A	Landing Length (in)	N/A	N/A	DWS Provided?	N/A
N/A	Landing Width (in)	N/A	N/A	DWS Contrast?	N/A
N/A	Landing Slope (%)	N/A	N/A	DWS Length (in)	N/A
N/A	Landing X Slope (%)	N/A	N/A	DWS Full Width?	N/A
N/A	Landing Curb? (Y/N)	N/A	N/A	DWS Offset (in)	N/A
N/A	Shared Landing?	N/A			
N/A	Gutter Ponding?	N/A	N/A	Gutter Slope (%)	N/A
N/A	Gutter Lip Ht (in)	N/A	N/A	Gutter X Slope (%)	N/A
N/A	Painted X Walk1?	Yes	N/A	Painted X Walk2?	N/A
	X Walk 1 Direction	To NE		X Walk 2 Direction	N/A
N/A	X Walk 1 Width (in)	113.0	N/A	X Walk 2 Width (in)	N/A
	X Walk 1 Slope (%)	0.4		X Walk 2 Slope (%)	N/A
	X Walk 1 X Slope (%)	5.6		X Walk 2 X Slope (%)	N/A

N/A	Ramp inside XWalk1?	Yes	N/A	Ramp inside XWalk2?	N/A
	Road Slope (%)	N/A	N/A	Clear Space?	N/A
	Road X Slope (%)	N/A	N/A	Clear Space to XWalk (in)	N/A
N/A	Any Obstructions?	N/A	N/A	Storm Grate/Utility Hazard?	N/A
	Obstruction Type			Storm Grate/Utility Type	
		N/A			N/A
		Yes		Surface Condition? (G/P)	Good

Possible Solutions:

**Remove & Replace Entire Ramp.**
