# Access Compliance Report

## Public Rights-of-Way

### (Curb Ramps)

Intersection ID: 13450	Main Street: S_MCDOWELL_ST	Cross Street: E_MARTIN_LUTHER_KING_JR_BV	Location: W
ADA ID: 986C6E690BE8	Ramp Type: PerpDiag	Initial Pass/Fail: Fail	Overall Compliance: No
Codes/Mitigation Info/Possible Solution		Field Measurements/Component Compliance	
Severity Score: 8.75

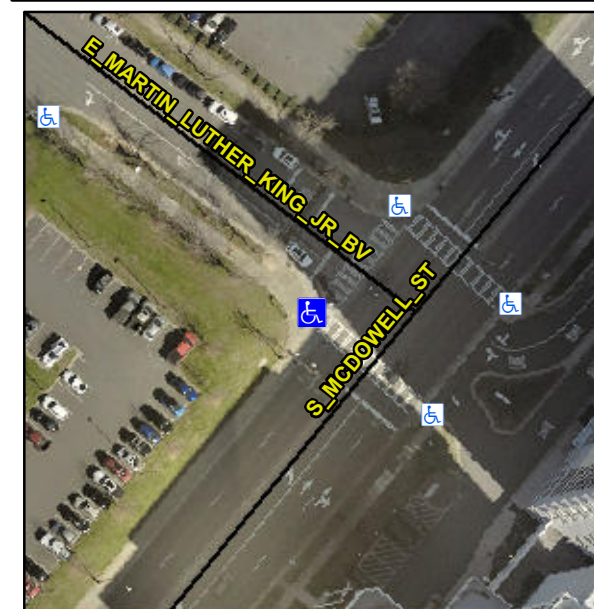
Compliance	Description	Data	Compliance	Description	Data
N/A	Ramp Length (in)	57.0	Yes	Ramp Slope (%)	6.1
No	Ramp Width (in)	37.0	Yes	Ramp XSlope (%)	1.5
N/A	Flare Type LT	N/A	N/A	Flare Type RT	N/A
N/A	Flare Slope LT (%)	N/A	N/A	Flare Slope RT (%)	N/A
N/A	Flare Traversable LT?	N/A	N/A	Flare Traversable RT?	N/A
N/A	Landing Length (in)	N/A	N/A	DWS Provided?	N/A
N/A	Landing Width (in)	N/A	N/A	DWS Contrast?	N/A
N/A	Landing Slope (%)	N/A	N/A	DWS Length (in)	N/A
N/A	Landing X Slope (%)	N/A	N/A	DWS Full Width?	N/A
N/A	Landing Curb? (Y/N)	N/A	N/A	DWS Offset (in)	N/A
N/A	Shared Landing?	N/A			
N/A	Gutter Ponding?	N/A	N/A	Gutter Slope (%)	N/A
N/A	Gutter Lip Ht (in)	N/A	N/A	Gutter X Slope (%)	N/A
N/A	Painted X Walk1?	Yes	N/A	Painted X Walk2?	Yes
	X Walk 1 Direction	To SE		X Walk 2 Direction	To NE
N/A	X Walk 1 Width (in)	111.0	N/A	X Walk 2 Width (in)	120.0
	X Walk 1 Slope (%)	1.6		X Walk 2 Slope (%)	0.1
	X Walk 1 X Slope (%)	1.4		X Walk 2 X Slope (%)	0.7

N/A	Ramp inside XWalk1?	Yes	N/A	Ramp inside XWalk2?	Yes
	Road Slope (%)	0.9	N/A	Clear Space?	N/A
	Road X Slope (%)	0.3	N/A	Clear Space to XWalk (in)	N/A
N/A	Any Obstructions?	N/A	N/A	Storm Grate/Utility Hazard?	N/A
	Obstruction Type			Storm Grate/Utility Type	
		N/A			N/A
		Yes		Surface Condition? (G/P)	Good

**Remove & Replace Curb Ramp With Two New Directional Ramps or Equivalent.**

**Not Found, R304.5.1**
