Access Compliance Report

Public Rights-of-Way

(Curb Ramps)

Intersection ID: 54779	Main Street: SHARON AMITY RD	Cross Street: CHARLESTON DR	Location: SE
ADA ID: 987488F85288	Ramp Type: Perp	Initial Pass/Fail: Fail	Overall Compliance: No
Codes/Mitigation Info/Possible Solution			Severity Score: 25
			Field Measurements/Component Compliance

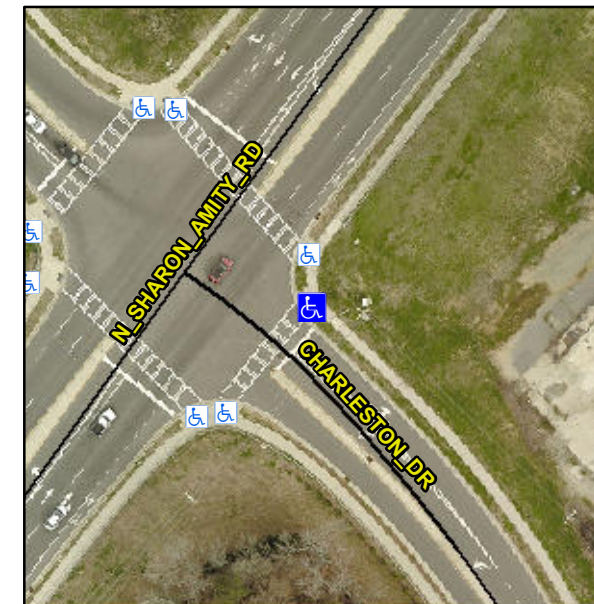
Compliance	Description	Data	Compliance	Description	Data
N/A	Ramp Length (in)	66.0	No	Ramp Slope (%)	8.8
Yes	Ramp Width (in)	59.0	No	Ramp XSlope (%)	5.7
N/A	Flare Type LT	N/A	N/A	Flare Type RT	N/A
N/A	Flare Slope LT (%)	N/A	N/A	Flare Slope RT (%)	N/A
N/A	Flare Traversable LT?	N/A	N/A	Flare Traversable RT?	N/A
N/A	Landing Length (in)	N/A	N/A	DWS Provided?	N/A
N/A	Landing Width (in)	N/A	N/A	DWS Contrast?	N/A
N/A	Landing Slope (%)	N/A	N/A	DWS Length (in)	N/A
N/A	Landing X Slope (%)	N/A	N/A	DWS Full Width?	N/A
N/A	Landing Curb? (Y/N)	N/A	N/A	DWS Offset (in)	N/A
N/A	Shared Landing?	N/A			
N/A	Gutter Ponding?	N/A	N/A	Gutter Slope (%)	N/A
N/A	Gutter Lip Ht (in)	N/A	N/A	Gutter X Slope (%)	N/A
N/A	Painted X Walk1?	Yes	N/A	Painted X Walk2?	N/A
	X Walk 1 Direction	To SW		X Walk 2 Direction	N/A
N/A	X Walk 1 Width (in)	103.0	N/A	X Walk 2 Width (in)	N/A
	X Walk 1 Slope (%)	3.4		X Walk 2 Slope (%)	N/A
	X Walk 1 X Slope (%)	4.3		X Walk 2 X Slope (%)	N/A

N/A	Ramp inside XWalk1?	Yes	N/A	Ramp inside XWalk2?	N/A
	Road Slope (%)	N/A	N/A	Clear Space?	N/A
	Road X Slope (%)	N/A	N/A	Clear Space to XWalk (in)	N/A
N/A	Any Obstructions?	N/A	N/A	Storm Grate/Utility Hazard?	N/A
	Obstruction Type			Storm Grate/Utility Type	
		N/A			N/A
			Yes	Surface Condition? (G/P)	Good

Remove & Replace Entire Ramp.
