# Access Compliance Report

## Public Rights-of-Way

### (Curb Ramps)

Intersection ID: 2711	Main Street: FAIRWAY_POINT_DR	Cross Street: RAVENCREST_DR	Location: NE
ADA ID: 987DCE1EEE27	Ramp Type: BlendTrans1	Initial Pass/Fail: Fail	Overall Compliance: No
			Severity Score: 33.75

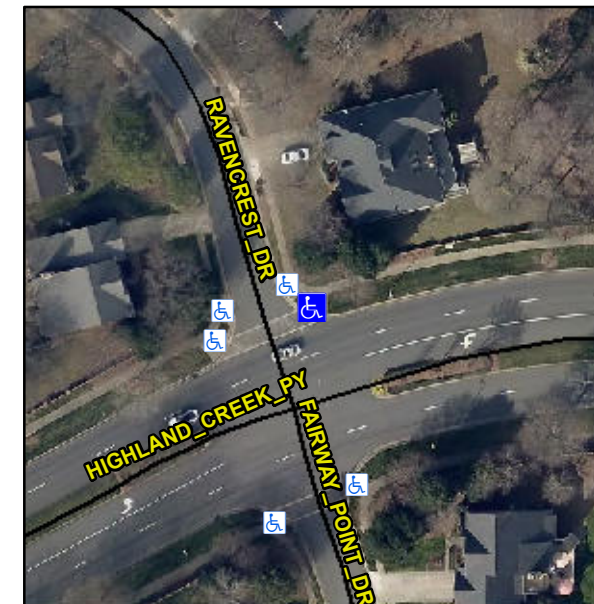
**GTR GAP 1.0**

**Not Found, R304.5.1, R304.5.3**

**Remove & Replace Curb Ramp With Two New Directional Ramps or Equivalent.**

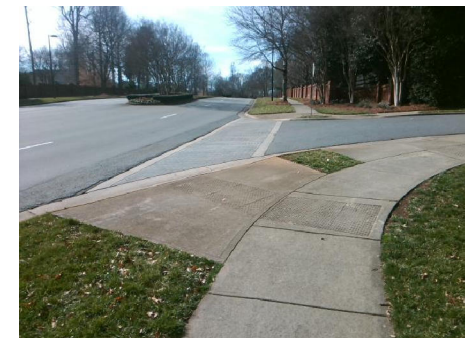
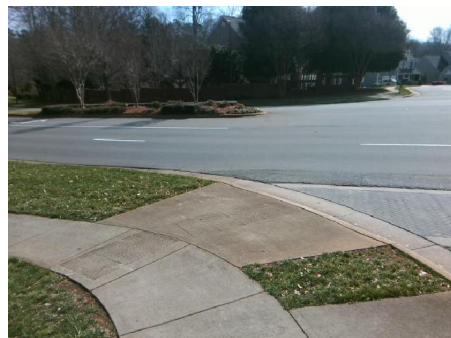
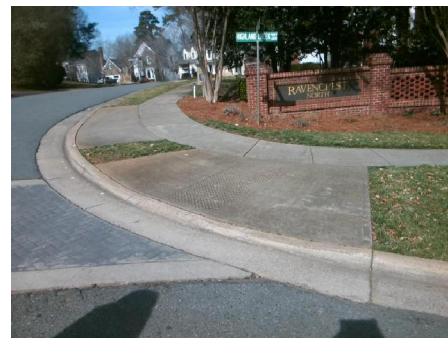
Compliance	Description	Data	Compliance	Description	Data
N/A	Ramp Length (in)	101.0	Yes	BlendTrans Slope (%)	0.6
No	Ramp Width (in)	36.0	No	BlendTrans XSlope (%)	9.2
N/A	Flare Type LT	N/A	N/A	Flare Type RT	N/A
N/A	Flare Slope LT (%)	N/A	N/A	Flare Slope RT (%)	N/A
N/A	Flare Traversable LT?	N/A	N/A	Flare Traversable RT?	N/A
N/A	Landing Length (in)	N/A	N/A	DWS Provided?	N/A
N/A	Landing Width (in)	N/A	N/A	DWS Contrast?	N/A
N/A	Landing Slope (%)	N/A	N/A	DWS Length (in)	N/A
N/A	Landing X Slope (%)	N/A	N/A	DWS Full Width?	N/A
N/A	Landing Curb? (Y/N)	N/A	N/A	DWS Offset (in)	N/A
N/A	Shared Landing?	N/A			
N/A	Gutter Ponding?	N/A	N/A	Gutter Slope (%)	N/A
N/A	Gutter Lip Ht (in)	N/A	N/A	Gutter X Slope (%)	N/A
N/A	Painted X Walk1?	No	N/A	Painted X Walk2?	No
	X Walk 1 Direction	To W		X Walk 2 Direction	To S
	X Walk 1 Width (in)	N/A		X Walk 2 Width (in)	N/A
	X Walk 1 Slope (%)	4.7		X Walk 2 Slope (%)	2.4
	X Walk 1 X Slope (%)	5.1		X Walk 2 X Slope (%)	6.8

N/A	Ramp inside XWalk1?	N/A	N/A	Ramp inside XWalk2?	N/A
	Road Slope (%)	8.8		Clear Space?	N/A
	Road X Slope (%)	0.1	N/A	Clear Space to XWalk (in)	N/A
N/A	Any Obstructions?	N/A	N/A	Storm Grate/Utility Hazard?	N/A
	Obstruction Type			Storm Grate/Utility Type	
		N/A			N/A
			Yes	Surface Condition? (G/P)	Good
			No	Curb Slope (%)	22.0
