Access Compliance Report

Public Rights-of-Way

(Curb Ramps)

Intersection ID: 12806	Main Street: E_STONEWALL_ST	Cross Street: S_COLLEGE_ST	Location: E
ADA ID: 9885C03A5396	Ramp Type: Perp	Initial Pass/Fail: Fail	Overall Compliance: No
Severity Score: 10			
Codes/Mitigation Info/Possible Solution		Field Measurements/Component Compliance

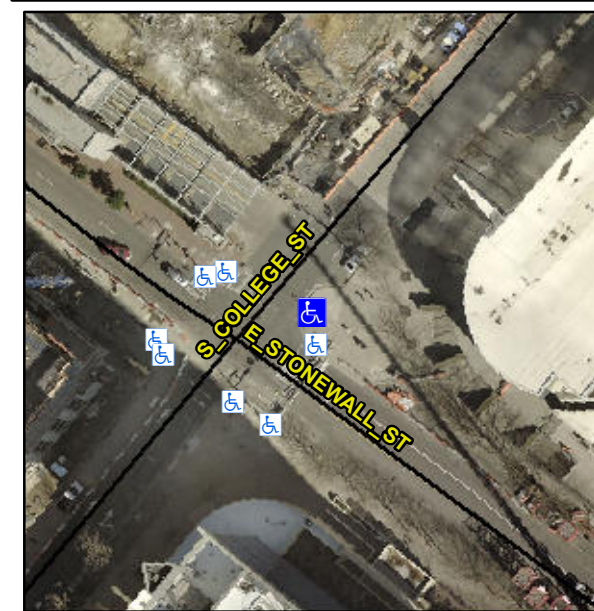
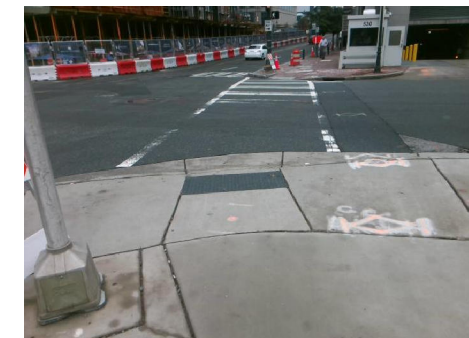
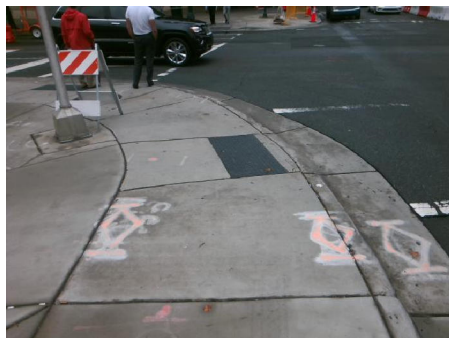
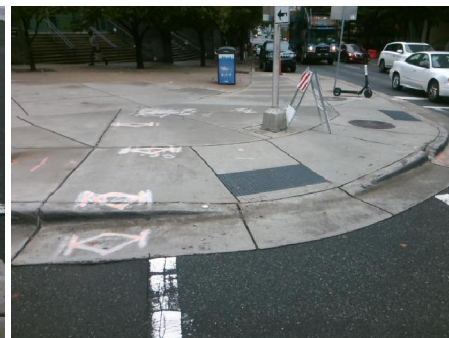
Not Found, R304.5.1, R304.5.3

Compliance	Description	Data	Compliance	Description	Data
N/A	Ramp Length (in)	73.0	Yes	Ramp Slope (%)	6.1
No	Ramp Width (in)	47.0	No	Ramp XSlope (%)	3.0
N/A	Flare Type LT	N/A	N/A	Flare Type RT	N/A
N/A	Flare Slope LT (%)	N/A	N/A	Flare Slope RT (%)	N/A
N/A	Flare Traversable LT?	N/A	N/A	Flare Traversable RT?	N/A
N/A	Landing Length (in)	N/A	N/A	DWS Provided?	N/A
N/A	Landing Width (in)	N/A	N/A	DWS Contrast?	N/A
N/A	Landing Slope (%)	N/A	N/A	DWS Length (in)	N/A
N/A	Landing X Slope (%)	N/A	N/A	DWS Full Width?	N/A
N/A	Landing Curb? (Y/N)	N/A	N/A	DWS Offset (in)	N/A
N/A	Shared Landing?	N/A			
N/A	Gutter Ponding?	N/A	N/A	Gutter Slope (%)	N/A
N/A	Gutter Lip Ht (in)	N/A	N/A	Gutter X Slope (%)	N/A
N/A	Painted X Walk1?	Yes	N/A	Painted X Walk2?	N/A
	X Walk 1 Direction	To NW		X Walk 2 Direction	N/A
N/A	X Walk 1 Width (in)	114.0	N/A	X Walk 2 Width (in)	N/A
	X Walk 1 Slope (%)	2.8		X Walk 2 Slope (%)	N/A
	X Walk 1 X Slope (%)	1.7		X Walk 2 X Slope (%)	N/A

N/A	Ramp inside XWalk1?	Yes	N/A	Ramp inside XWalk2?	N/A
	Road Slope (%)	N/A	N/A	Clear Space?	N/A
	Road X Slope (%)	N/A	N/A	Clear Space to XWalk (in)	N/A
N/A	Any Obstructions?	N/A	N/A	Storm Grate/Utility Hazard?	N/A
	Obstruction Type			Storm Grate/Utility Type	
		N/A			N/A
			Yes	Surface Condition? (G/P)	Good

Remove & Replace Entire Ramp.

Total Cost: \$ 1850.00
