# Access Compliance Report

## Public Rights-of-Way

### (Curb Ramps)

| Intersection ID: 50598 | Main Street: BENDING_BRANCH_RD | Cross Street: BEAR_GRASS_LN | Location: S |

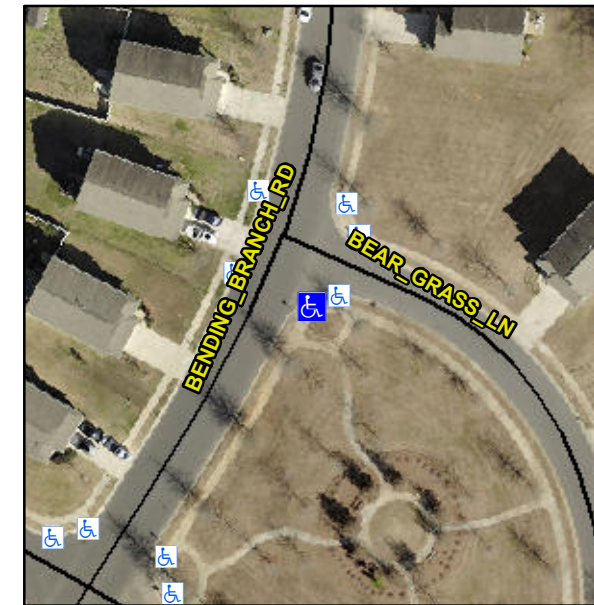
**Not Found, R304.2.2-Perp, R304.3.2-  
Para, R304.5.4**

| Compliance | Description | Data | Compliance | Description | Data |
|---|---|---|---|---|---|
| No | Landing Slope (%) | 4.2 | Yes | DWS Length (in) | 24.0 |
| Yes | Gutter Ponding? | No | No | Gutter Slope (%) | 11.6 |

**Remove & Replace Entire Ramp.  
Remove & Replace Gutter.**
